**City Hall Salisbury
Malthouse Lane, Salisbury
SP2 7TU, UK**

**Suspended Plaster Ceilings
Inspection**

Prepared for
Kier Workplace Services

September 2020

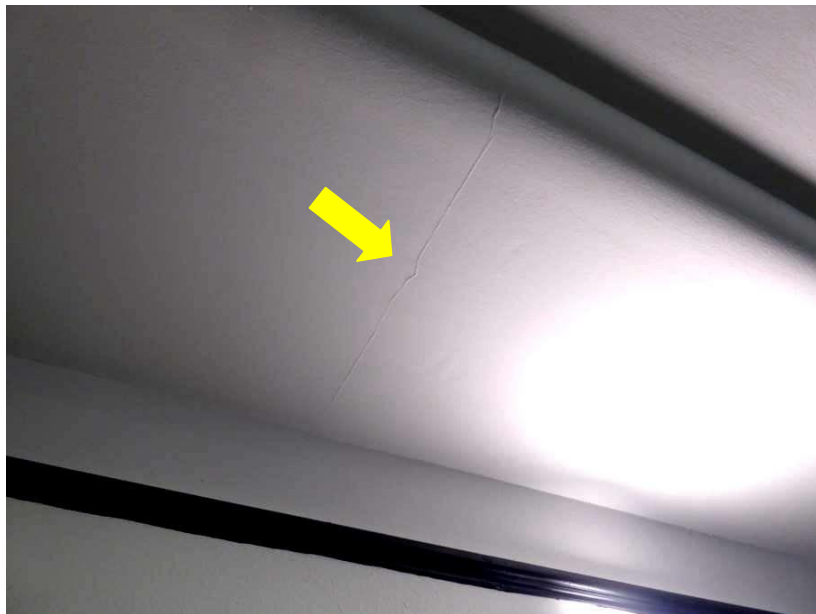
- 3.1.3.2 In the area of the front entrance and ticket office the historic suspended plastered ceiling was covered with a new structure, presumably plasterboard fixed over the original and historic elements.
- 3.1.3.3 Visually the ceiling plane had slight undulations, however the plain and decorative areas were sound and firm when pressure was applied. Cracking was seen intermittently, mostly along the South external wall and at approximately 4.0m centres. The cracking was below the painted surface and so was not active.

Photo 7 – Crack in Foyer ceiling.

- 5.5 In the Foyer area, provide safe access to the void above ceiling, to facilitate inspection of the whole area and assess condition of the ceiling's substructure, cast plaster panel attachments and plaster key attachments in the cracked areas.

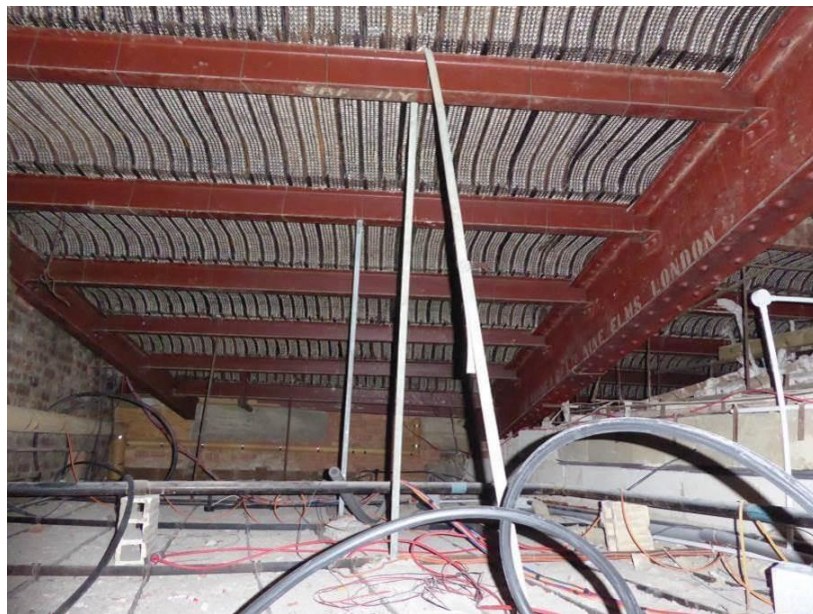
3.2.2.2 The ceiling structure was suspended with a few ties only. These ties were galvanized flat bars and appeared to be a modern alteration of the ceiling's structure. No hessian ties were observed in this area.

Photo 8 – ceiling void above Kitchen / Servery.

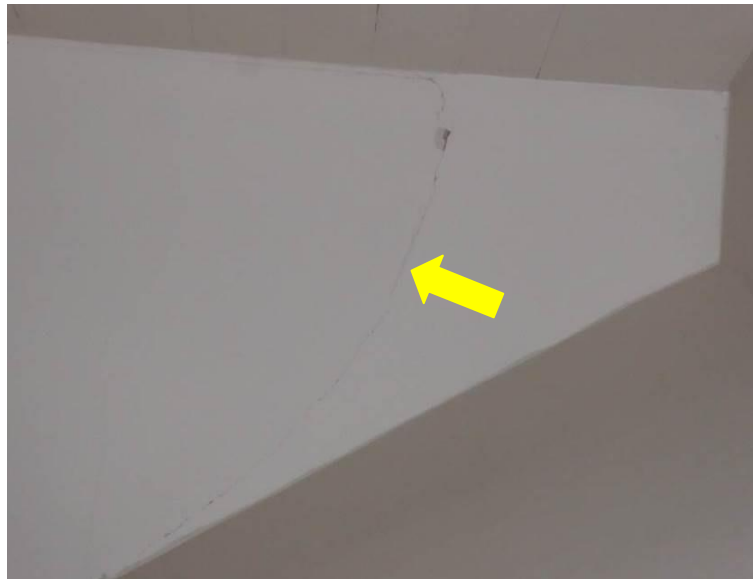
- 3.3.3.8 Cracking to left-hand side and right-hand side of the stage was noted. It appeared to be at the junction of historic suspended ceiling and modern ceiling infill. The immediate surrounding plasterwork was firm under applied hand pressure and sound.

Photo 26 – Crack to the left-hand side of the stage.

- 4.14 It is likely that the above alterations had some impact on the decorative panels of the ceiling, causing cracking and defects (hollow panels). The two cracks noted on right-hand side and left-hand side of the stage are not structural as the plasterwork was firm in the surrounding ceiling areas. It was likely that the cracks occurred at the junction between the historic ceiling and the modern replacement ceiling, due to the use of materials with different thermal characteristics used in their construction.

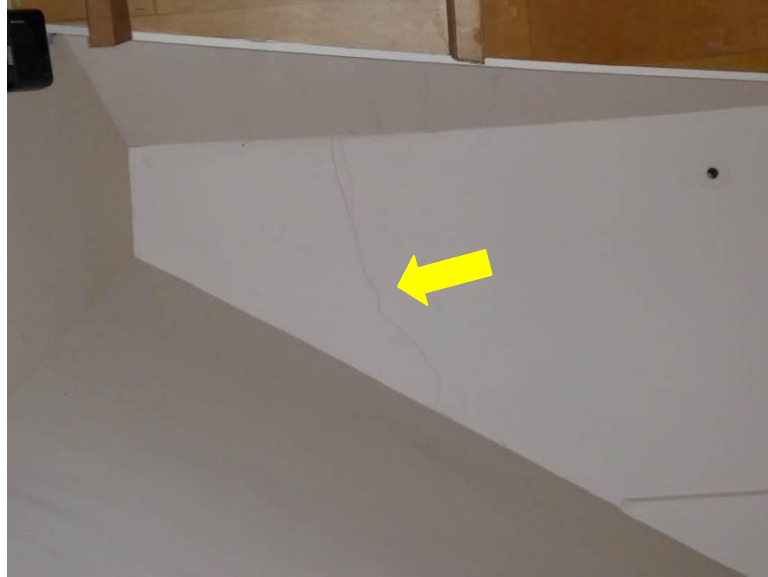
Photo 27 – Crack to the right-hand side of the stage.

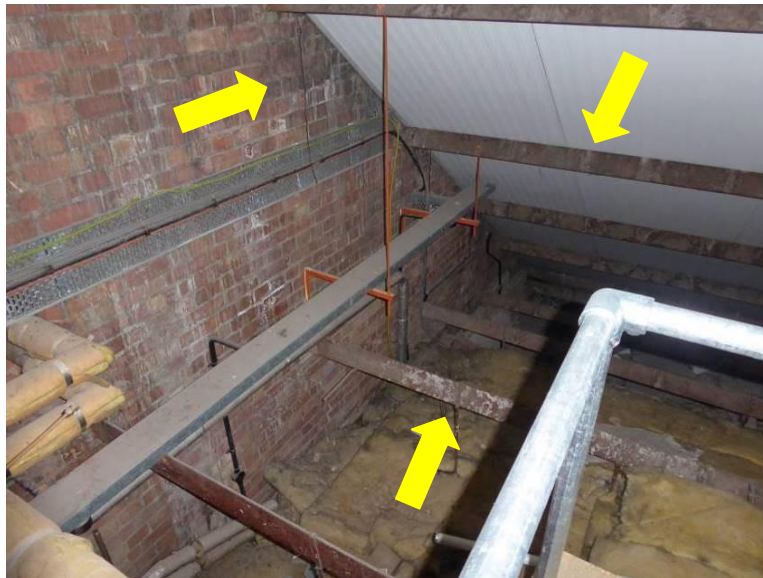
- 3.4.2.4 Staining on the supporting angles and purlins had been noted, which can indicate an issue with water penetration prior to the roof covering replacement. Corrosion of purlin bearings onto the external wall has been noted, together with cracking and displacement of the brickwork.

Photo 30 – Staining on supporting angles (secondary beams and purlins) and wall.

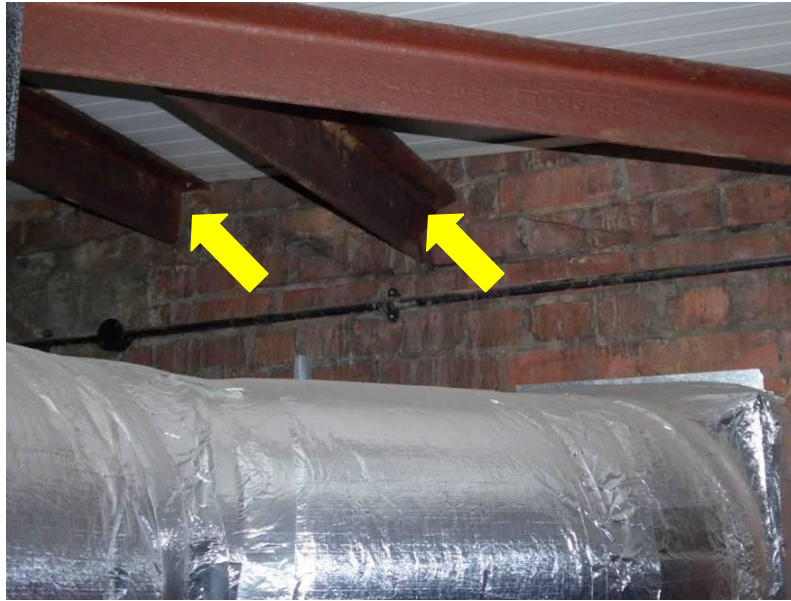
Photo 31 – Surface corrosion of purlins bearing on external wall.

- 4.12 Where inspected we have not noted any significant corrosion of structural elements except the bearings of the steel purlins in the external walls. Surface corrosion on steel trusses was noted in a few locations and this is part of the natural ageing process of the building structure. Although that is not a structural issue, the condition of the steelwork should be maintained and painted from time to time.

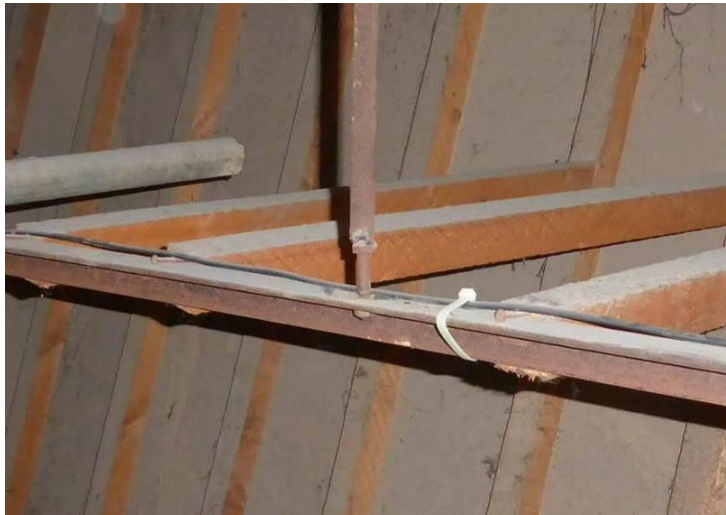
- 4.16 The modern ceiling and lighting rig were suspended off the historic supporting (roof) structure, which we found to have sufficient capacity. The timber structure forming the platform was sufficient to transfer the loadings on the platform. The flat bar and angle ties used to suspend the platform structure had sufficient tensile capacity, but the connection details were not adequate and in future may cause failure of the platform structure. The welding of hardened steel bolts to mild steel flat bar, as shown on picture below, does not provide full strength and may be susceptible to fracture and there was no backup support mechanism.

Photo 34 – Tie connection in the lighting platform's suspension system.

- 4.17 We also noted un-secured bolts in these connections, which increases stress on the surrounding ties and connections. In our opinion the suspension system used for the lighting rig requires a detailed assessment to confirm its viability.
- 4.18 The shear connections between angles forming suspension frame, secured with single bolts also need a detailed structural assessment. Secondary strap fixings may be required to minimise the risk of failure.

- 5.10 The construction details of the modern lighting platform next to the stage must be investigated and a detailed risk assessment undertaken. Remedial works may be required to provide durability of the suspension system and prevent risk of future failure.

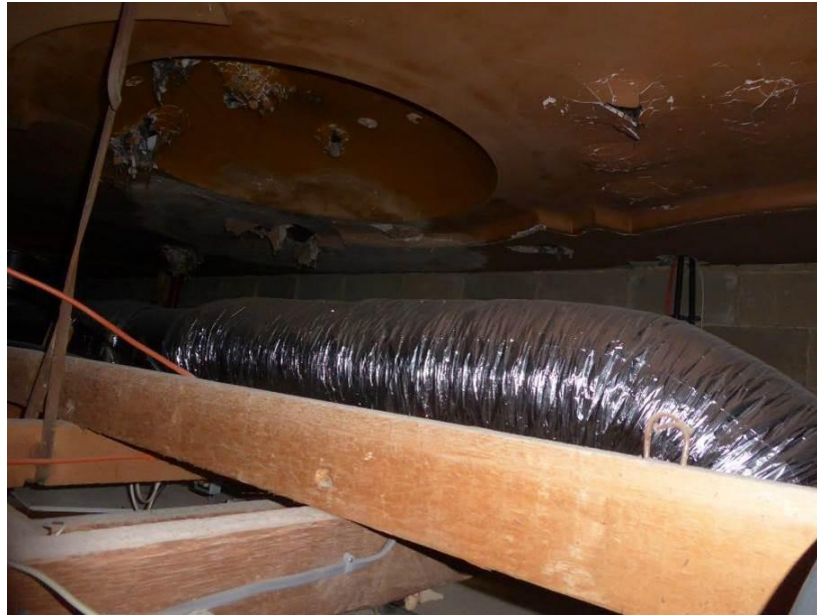
- 4.21 Due to access limitations the condition of the suspended plastered ceiling could not be inspected in detail. The visual inspection from below proved decorative features were installed in this area. We have also noted some damage on the historic ceiling with abraded / broken pieces of plaster remaining. These should be removed to prevent future failure. Staining / discolouration on the ceiling was observed, which can be evidence of historic water penetration through the roof covering (see photo 35 on next page). Considering the visual observation and findings in other areas, we think that condition of the ceiling must be inspected in detail and this should include plain areas and decorative plasterwork.

Photo 35 – Damaged underside of the ceiling over the Alamein Room.

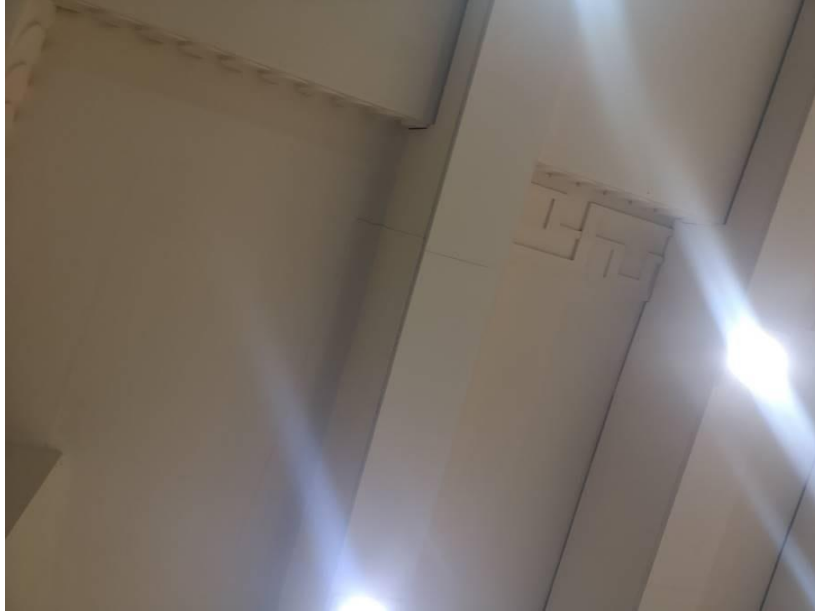
Photograph A2.1 – Auditorium ceiling showing downstand lighting boxes and section where there is no Greek key between High level and lowered ceiling. Possible recent repair.

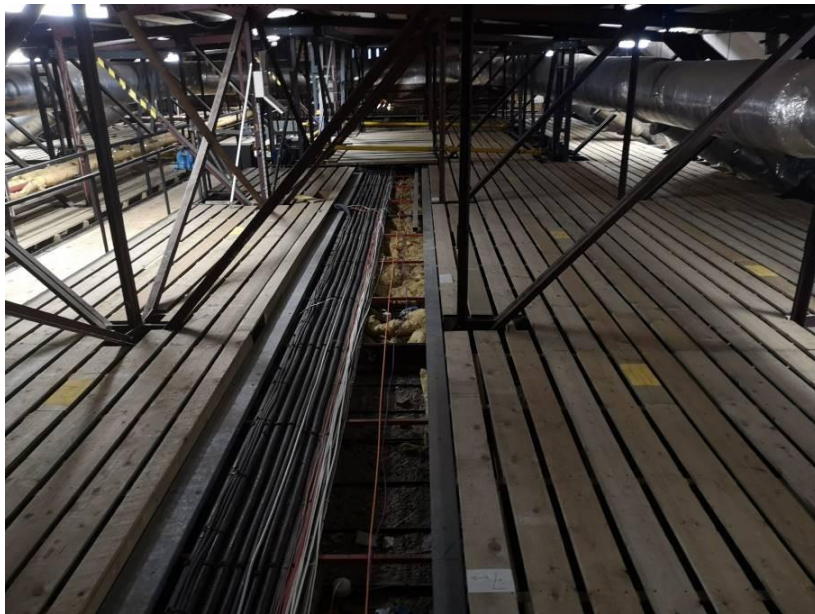
Photograph A2.2– Trusses above main auditorium ceiling where access was permitted on our first and second visits but restricted due to concerns over asbestos on our third visit.

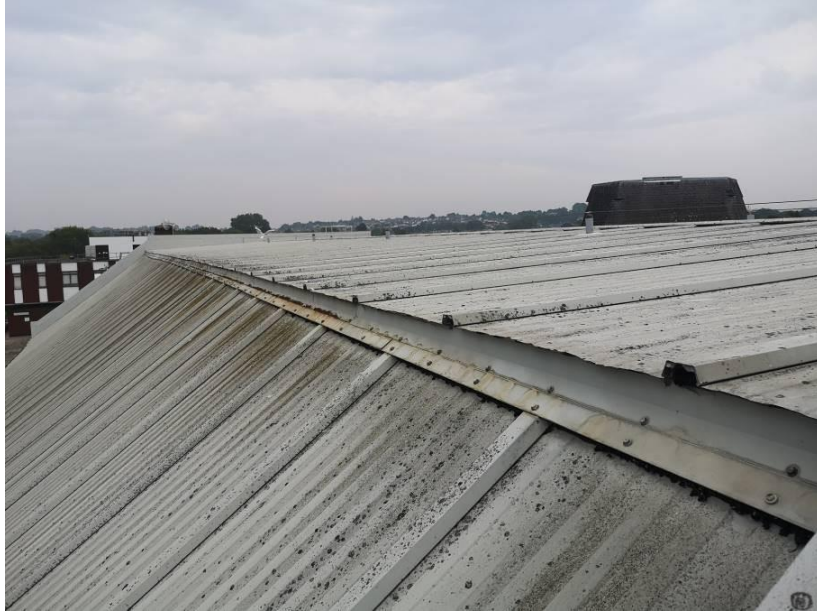
- 3.6.1 The lack of a cover flashing to the west ridge of the main auditorium roof was most disturbing and will lead to much more significant issues. There were no signs as to what may have happened to this flashing but the roof staining does suggest that it had at one time been fitted. The lack of a cover flashing can be seen on google maps suggesting it had been missing for some time.
- 3.6.2 The poor fitting of flashings around the access door also demonstrated a poor quality of workmanship and another potential source for water ingress.
- 3.6.3 Photos A2.12 and A2.14 show external parts of the east elevation that had been painted with non-breathable coatings, possibly to try and prevent moisture ingress.

Photograph A2.3 – West elevation, look north along ridge line to main auditorium roof – note the missing ridge flashing.

- 5.1 The priority has to be ensuring a safe secure weathertight envelope to the building. A sudden water ingress will rapidly destroy any internal ceilings whether in good condition or otherwise.

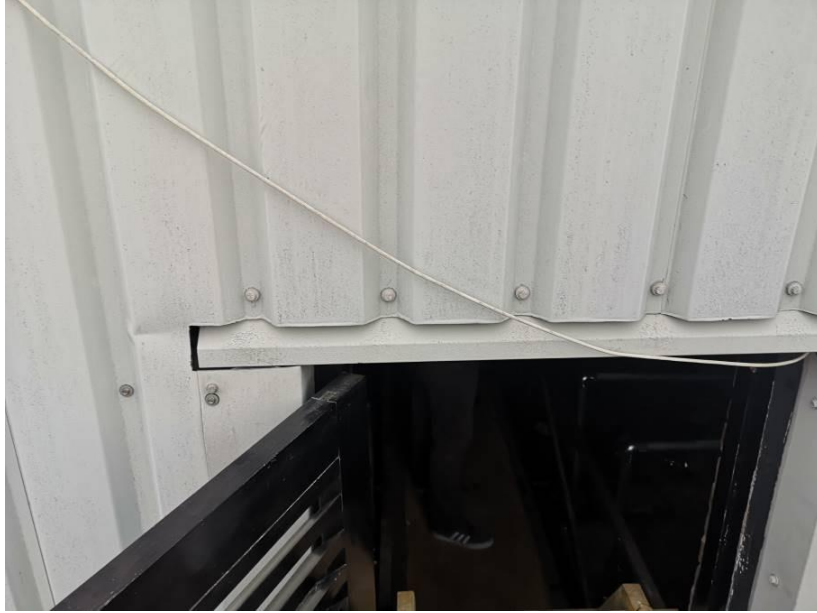
Photograph A2.5 – South elevation roof access door - Note the poor fitting flashing to top of door.

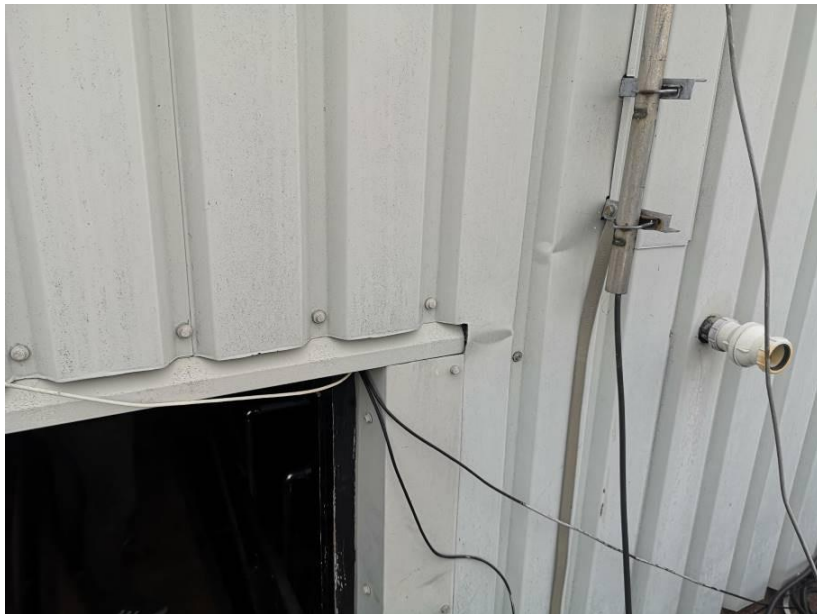
Photograph A2.6 – South elevation roof access door - Note the poor fitting flashing to top of door.

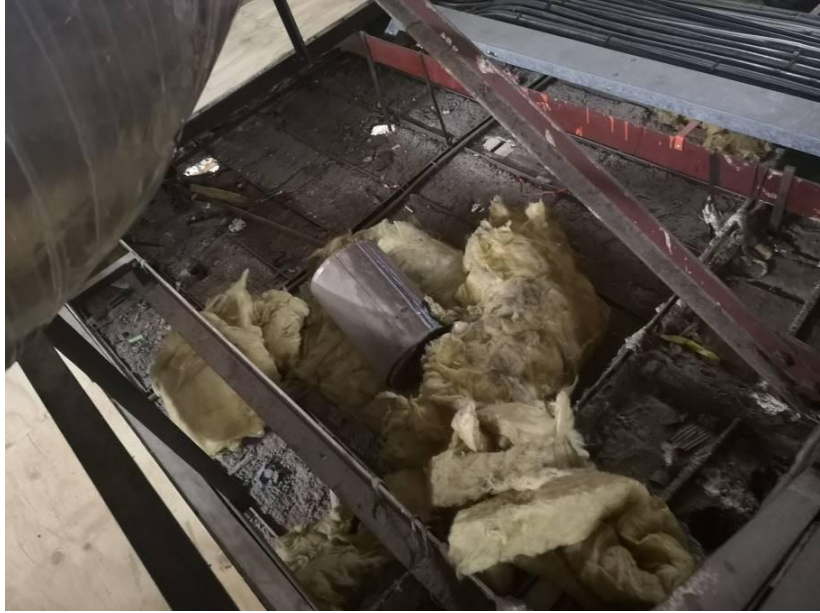
- 3.3.3.6 The cracking immediately in front of the lighting room was partially assessed on our third inspection from the scaffold tower. Ideally, we would have inspected from above. We have serious concerns over the management of ACM's having been allowed into the ceiling loft on two previous inspections. The area above the cracking is shown in photo: A2.7 in Appendix A.

- 3.3.3.7 If ACM's are present in the Main auditorium ceiling loft, then fibres will exist throughout the building. There were numerous openings in the main ceiling and combined with the lack of a properly encapsulated roof there is likely to often be a negative pressure in the audience space of the auditorium sucking fibres into this area. The expectation on the third visit was for the area shown in photo: A2.7 to be cleared and cleaned to enable a full and proper assessment of the overall ceiling condition to be made.

Photograph A2.7 – Loft side of high-level roof – showing numerous openings.

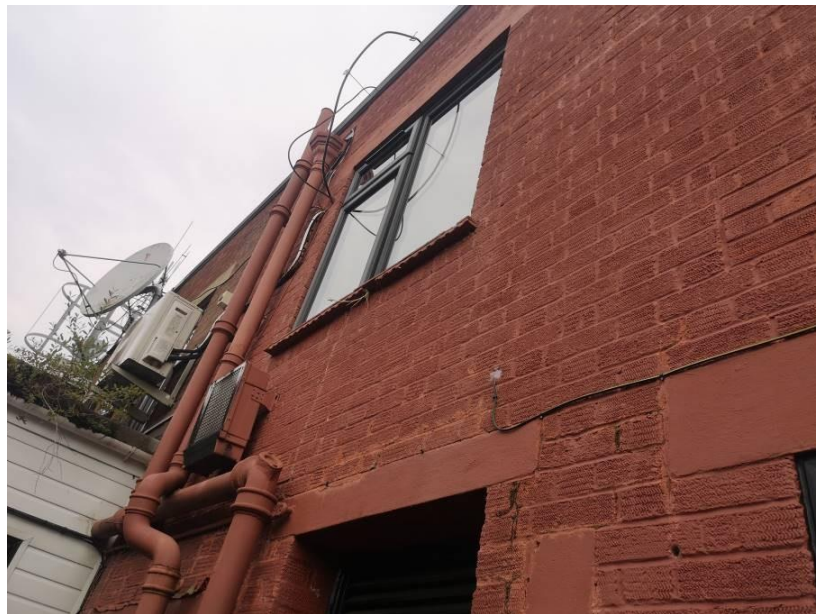
Photograph A2.12 – Part east elevation – Note brickwork has been painted with a non-breathable paint.

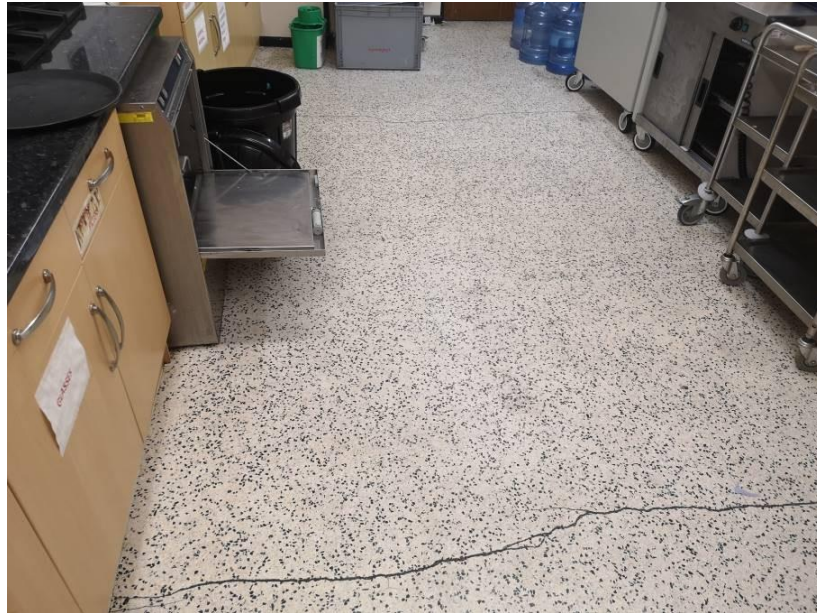
Photograph A2.13 – Regular east/west floor cracks to kitchen terrazzo finished floor at first floor level.

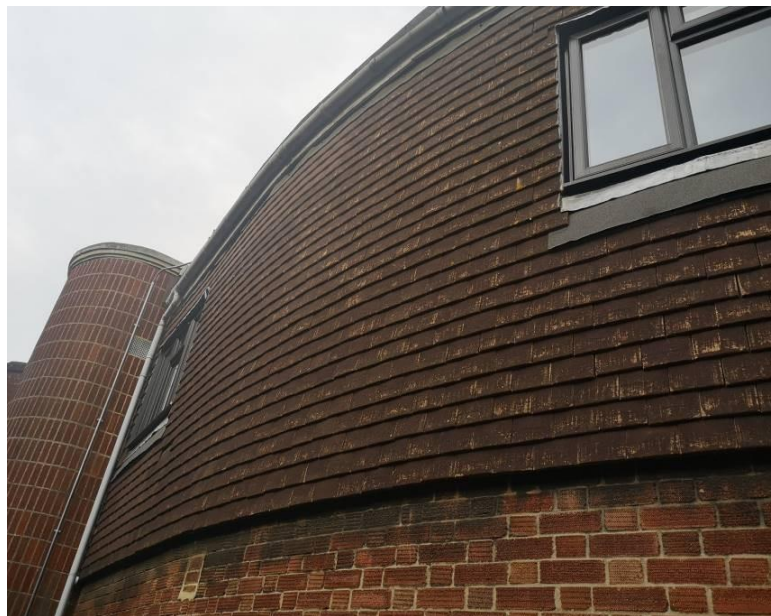
Photograph A2.14 – Part tile hun east elevation. Note tiles and some of the brickwork have been painted with a non-breathable coating.

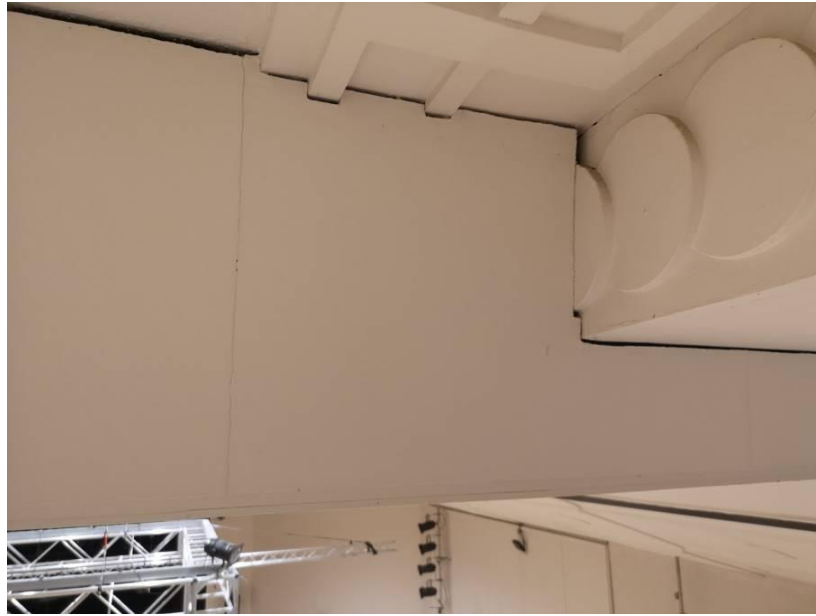
Photograph A3.3 – Typical detail of downstand lighting box showing gaps between horizontal and vertical boards.

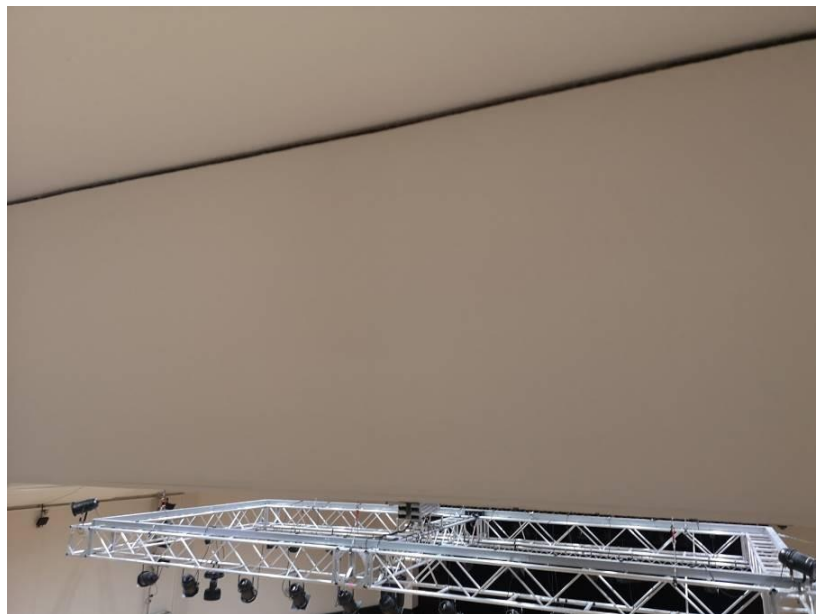
Photograph A3.4 – Typical gap between down stand lighting box and main ceiling as shown in photo A3.3 above.

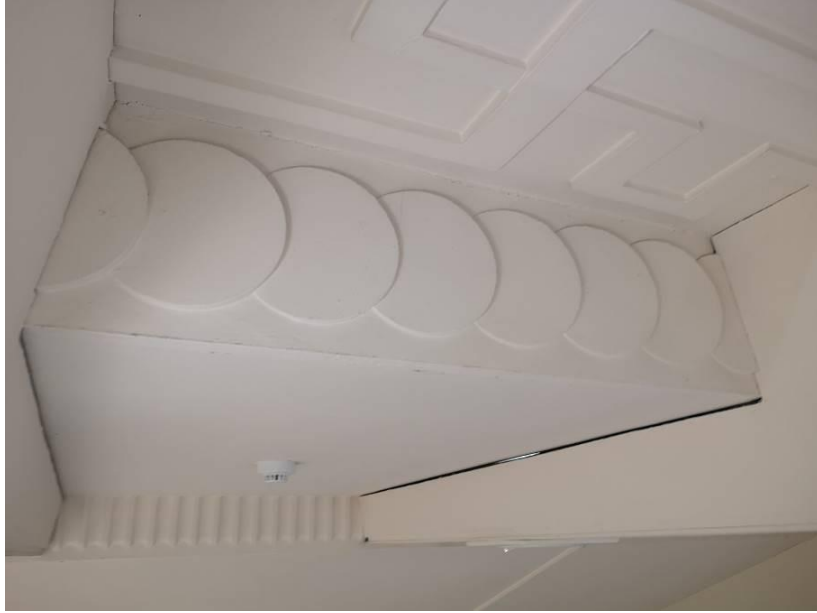
Photograph A3.5 – Typical gap between down stand lighting box and side lowered ceiling as shown in photo A3.2 above.

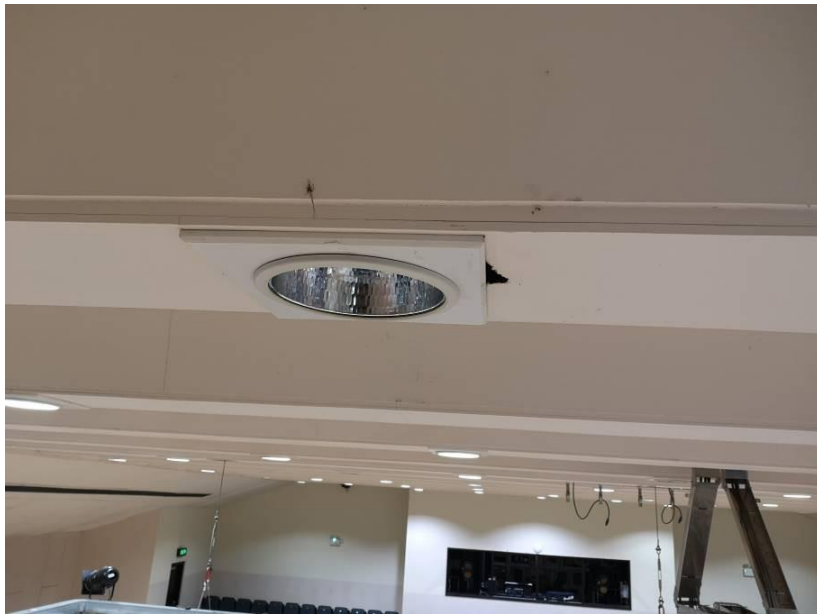
Photograph A3.6 – Typical light fitting to bottom of downstand showing over-sized opening in plasterboard.

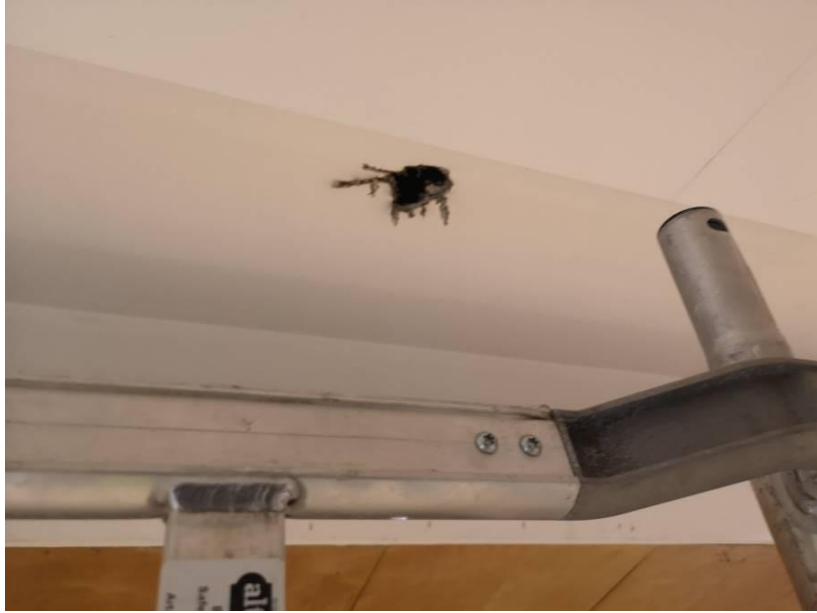
Photograph A3.7 – Hole noted to side of light fitting near to stage – appeared to have 'burnt through'

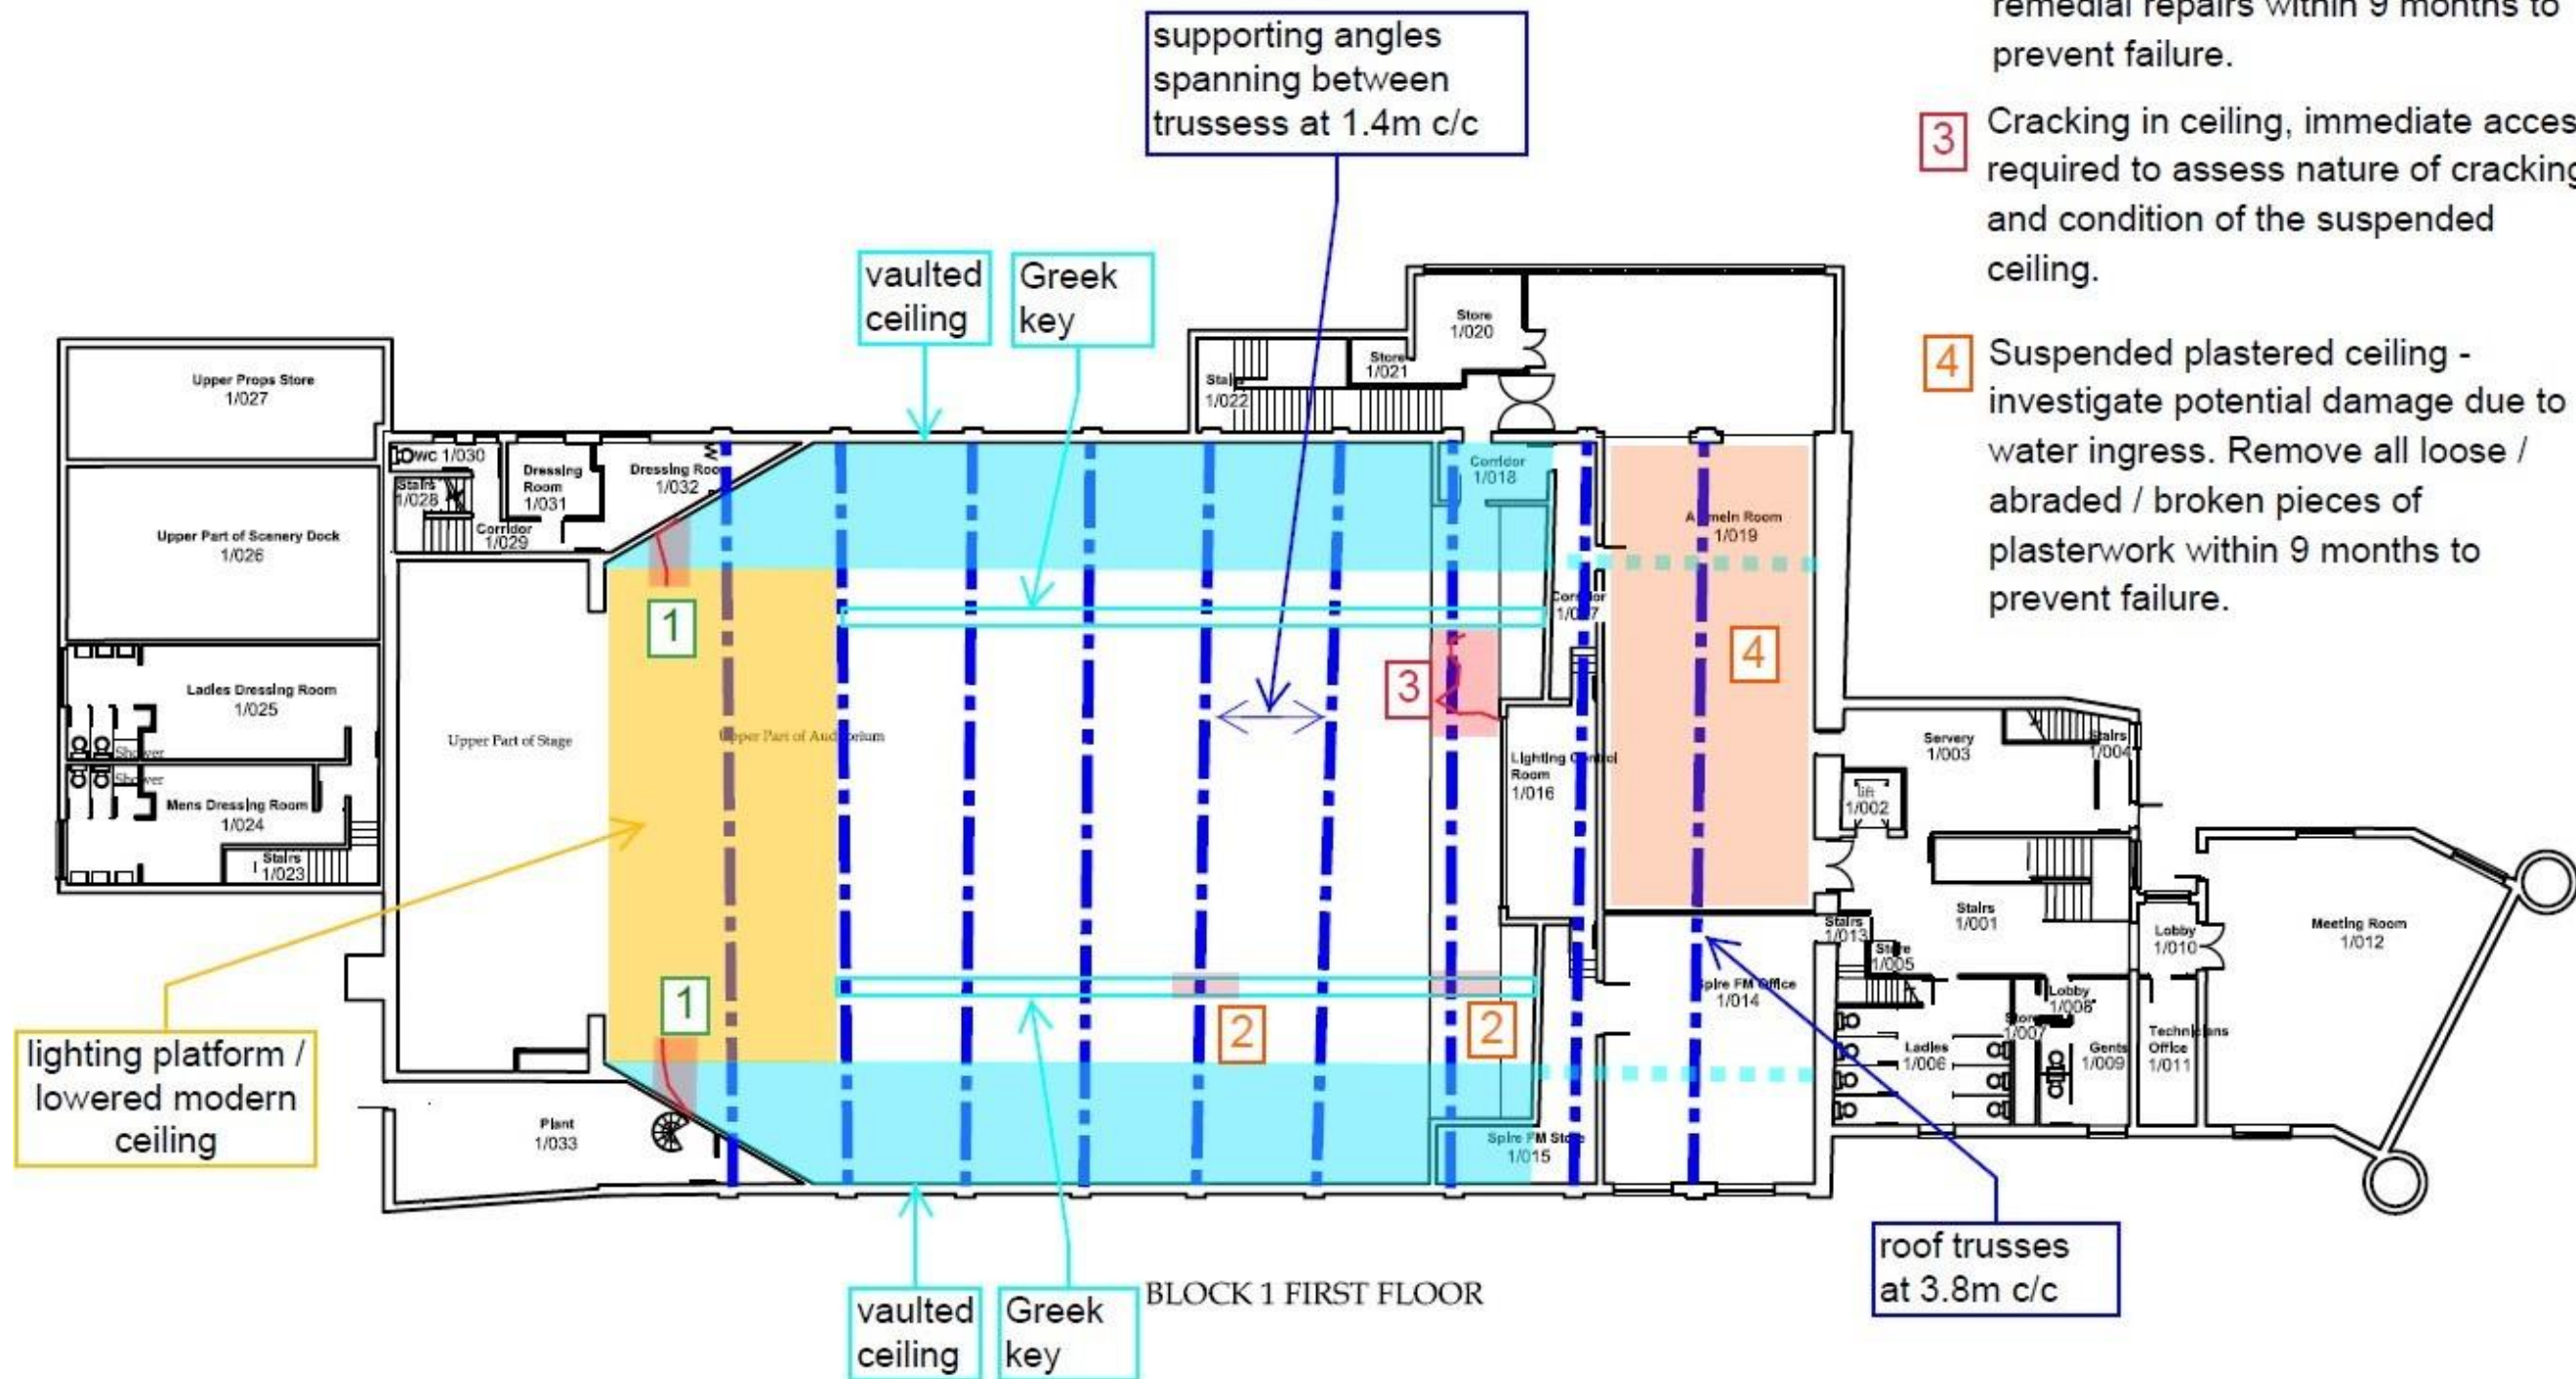
STRUCTURES AND DEFECTS CHART – FIRST FLOOR

- 1 Cracking on right-hand and left-hand side of the stage, not a structural issue but requiring repair and monitoring.
- 2 Cracking in Greek key decorative panels. Requires assessment and remedial repairs within 9 months to prevent failure.
- 3 Cracking in ceiling, immediate access required to assess nature of cracking and condition of the suspended ceiling.
- 4 Suspended plastered ceiling - investigate potential damage due to water ingress. Remove all loose / abraded / broken pieces of plasterwork within 9 months to prevent failure.

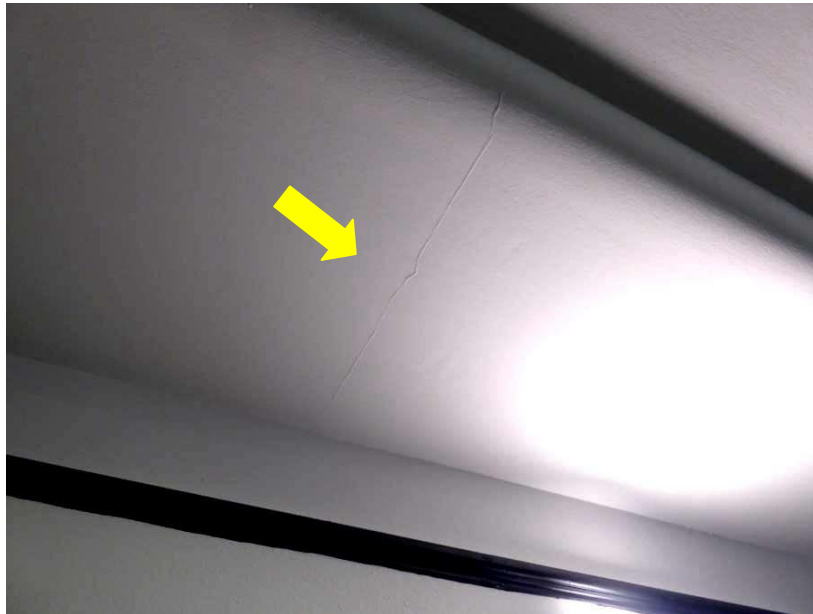
Visually the ceiling plane had slight undulations, however the plain and decorative areas were sound and firm when pressure was applied. Cracking was seen intermittently, mostly along the South external wall and at approximate 4.0m centres. The cracking was below the painted surface and so was not active / live.

Photo 7 – Crack in Foyer ceiling.

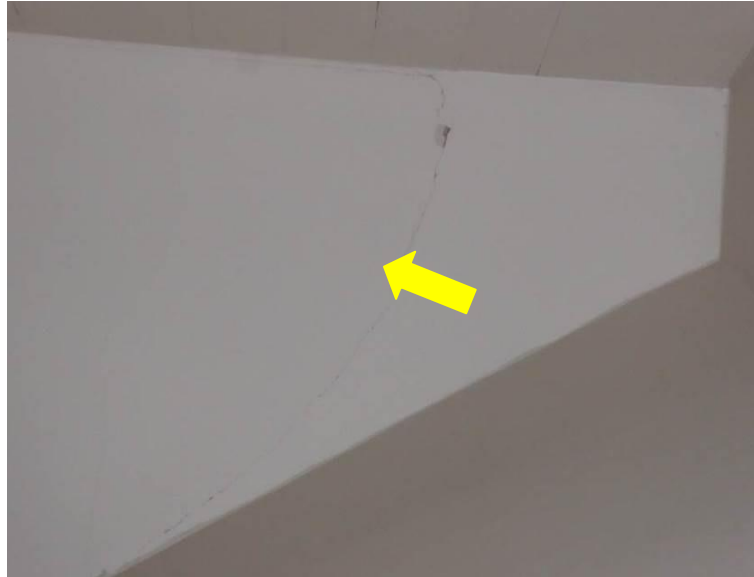
Photo 24 – Crack to the left-hand side of the stage.

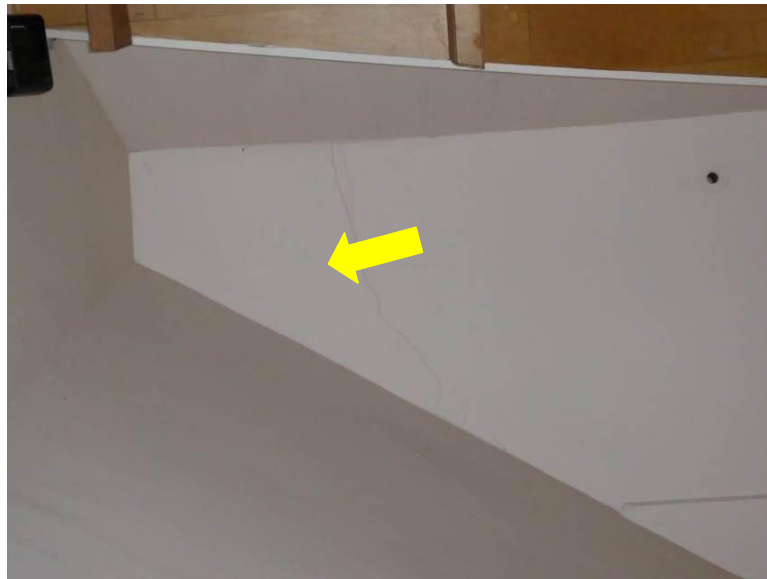
Photo 25 – Crack to the right-hand side of the stage.

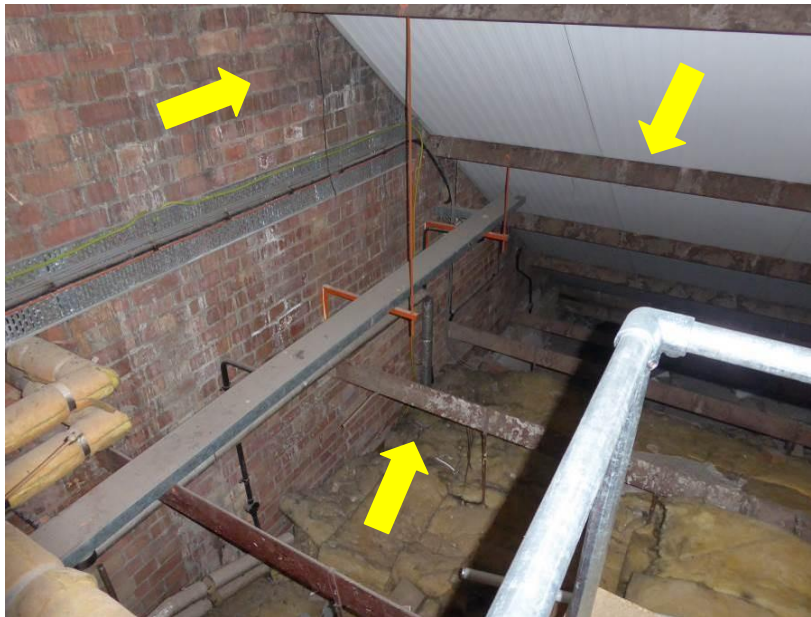
Photo 28 – Staining on supporting angles (secondary beams and purlins) and wall.

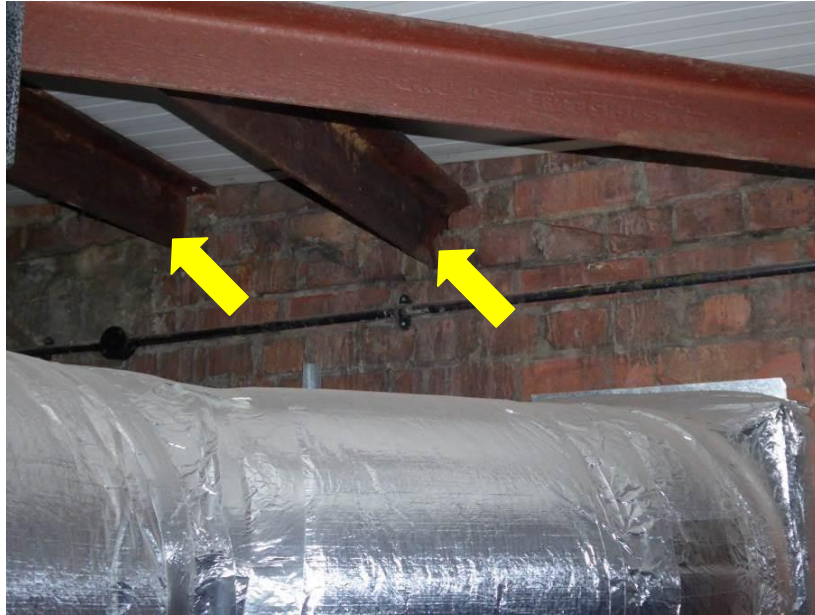
Photo 29 – Surface corrosion of purlins bearing on external wall.

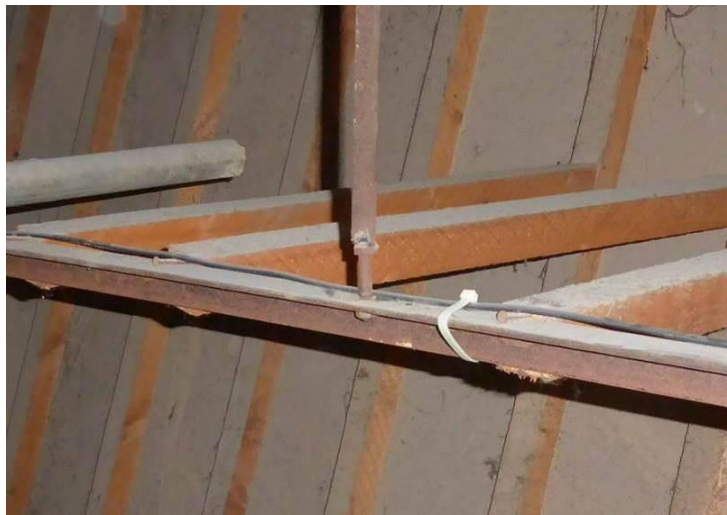
Photo 31 – Tie connection in the lighting platform's suspension system.

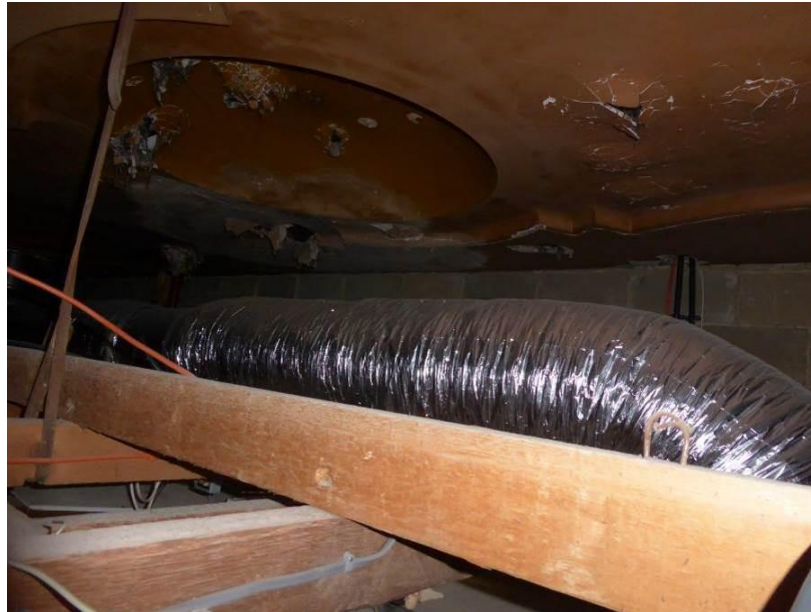
Photo 32 – Damaged underside of the ceiling over the Alamein Room.
