**City Hall Salisbury
Malthouse Lane, Salisbury
SP2 7TU, UK**

**Suspended Plaster Ceilings
Inspection**

Prepared for
Kier Workplace Services

September 2020

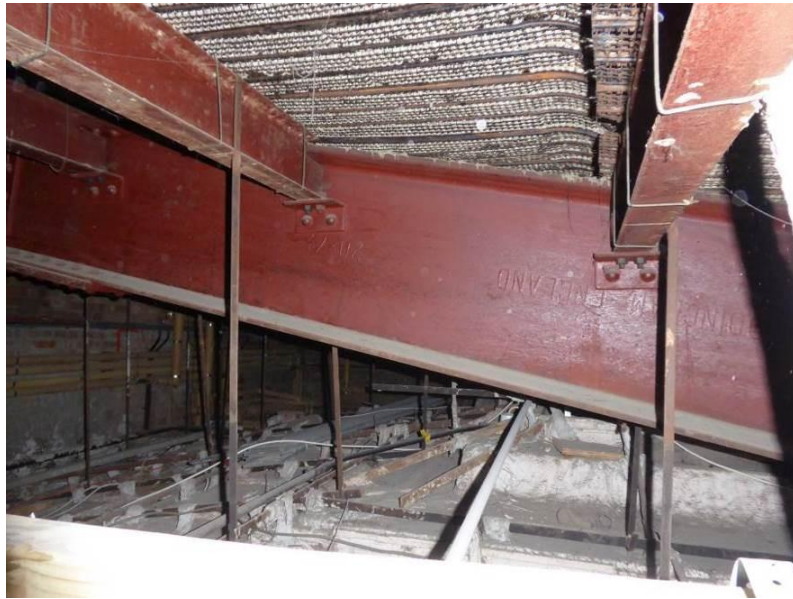
- 3.1.1 Good access below the ceiling was provided. Access above was only through the lighting panel opening in the ceiling, it was not possible to enter the ceiling void.
- 3.1.2 *Structural parts supporting the suspended plaster ceilings.*
- 3.1.2.1 The ceiling was suspended from the floor structure, originally forming the auditorium balcony. The structure was formed of deep cranked primary steel beams and secondary beams spanning between and supporting the stepped floor. The floor was presumably concrete cast on metal lath, tied to the steel beams with metal wire.

Photo 1 – Ceiling void above Foyer.

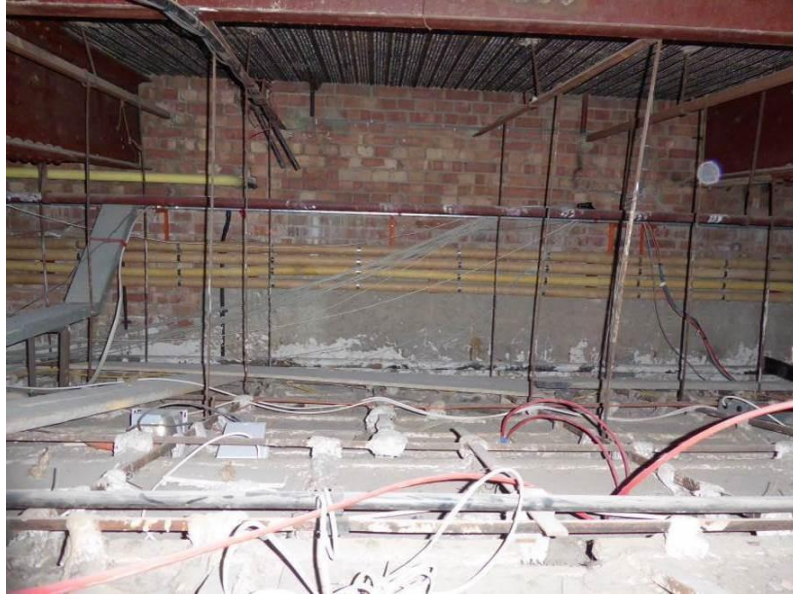
- 3.1.2.2 The ceiling structure was suspended with flat, twisted bars. These bars were hooked over the top flange off the secondary beams or fixed to the angles spanning between the secondary beam and masonry wall. There was no access to measure size and gauge of the ties. Beside flat bar ties, hessian wadding ties had been used to suspend the ceiling (ceiling over the part of Foyer abutting Auditorium). It was likely that the hessian wadding ties fixed to the secondary steel beams had metal wire reinforcement.

Photo 2 – Ceiling void above Foyer.

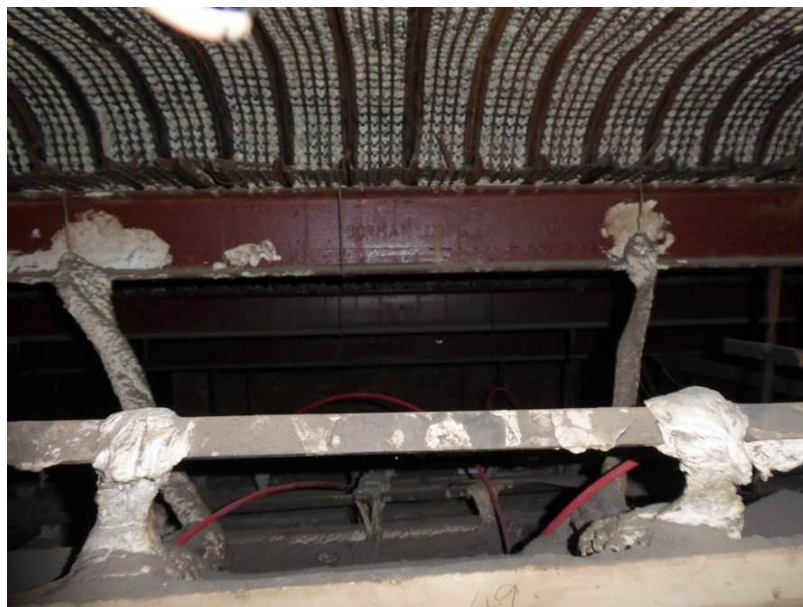
- 3.1.2.3 The substructure supporting the plastered ceiling was formed of mild steel flat bars placed in two layers and in orthogonal directions. Top layer was formed of 30x6mm flat bars, it was not possible to measure the exact size of the bottom layer flat bars but considering the construction of the ceiling in other areas they were likely to be 18x6mm.

Photo 3 – Hessian wadding ties supporting the suspended ceiling.

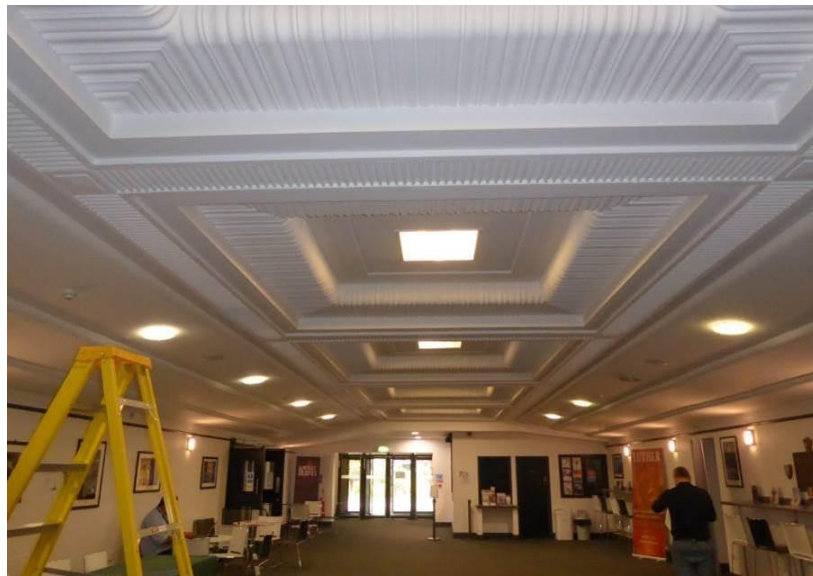
3.1.3.1 The ceiling was formed of solid work (cementitious mortar) applied to expanded metal lath. The lath was fixed to the ceiling's substructure with metal wire and hessian wadding ties. The finish was undetermined (possibly anhydrous plaster). The decorative plasterwork was cast fibrous plaster panels (hemihydrate plaster and hessian / timber reinforcement). The ceiling over the Foyer comprised five large coffers in the centre of the span with light fittings in the middle. It was noted that modern timber frames were introduced to support the ceiling around the light fittings in the centre of the coffers.

Photo 4 – The suspended ceiling over Foyer.

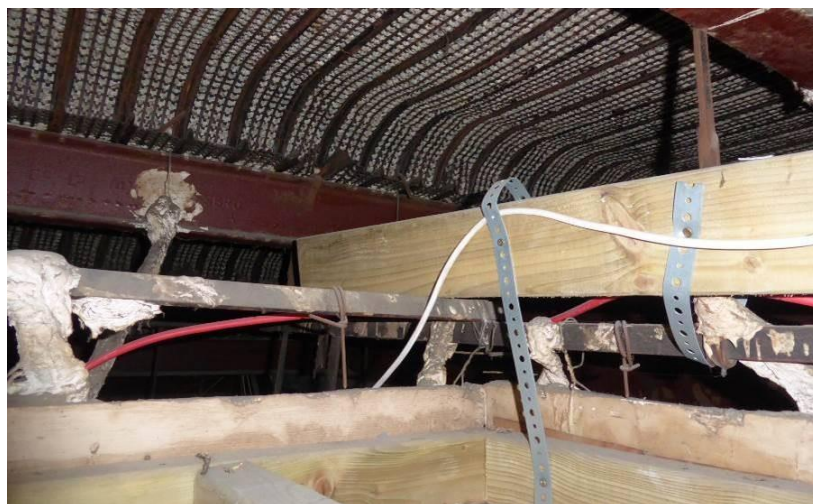
Photo 5 – Timber frame around light fitting, over the coffer.

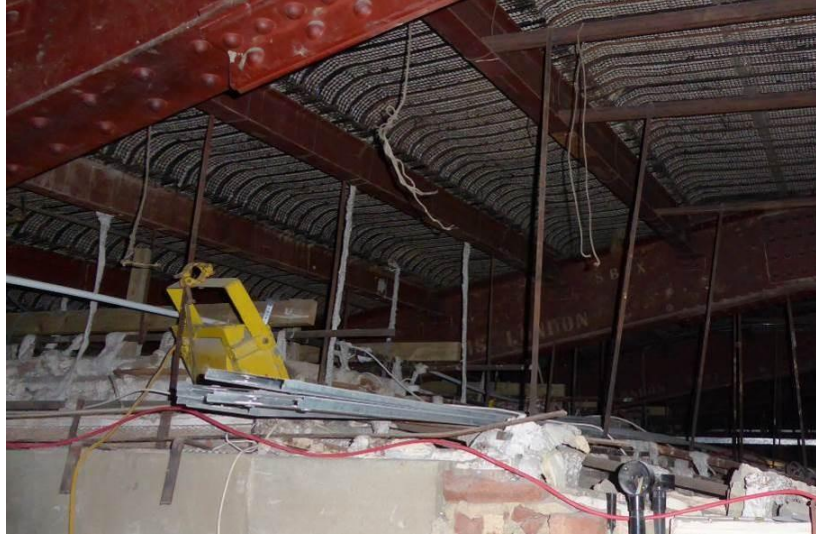
Photo 6 – Void over Foyer ceiling, timber frames over the coffers.

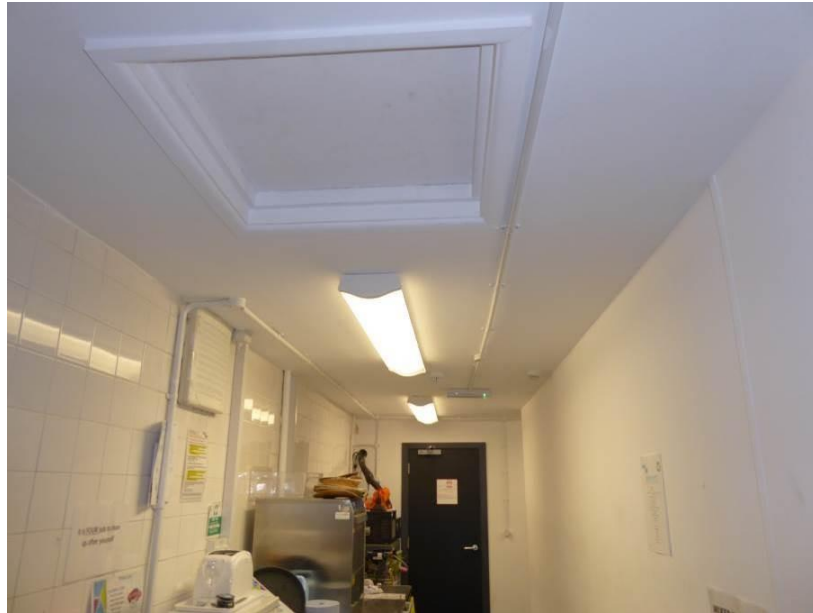
- 3.2.2.4 In the centre of the 3.5m span the ceiling had deflected, approximately 30mm, which was above the acceptable serviceability limit. The deflection most likely occurred before the partition wall was installed.

Photo 9 – Ceilings over the Kitchen.

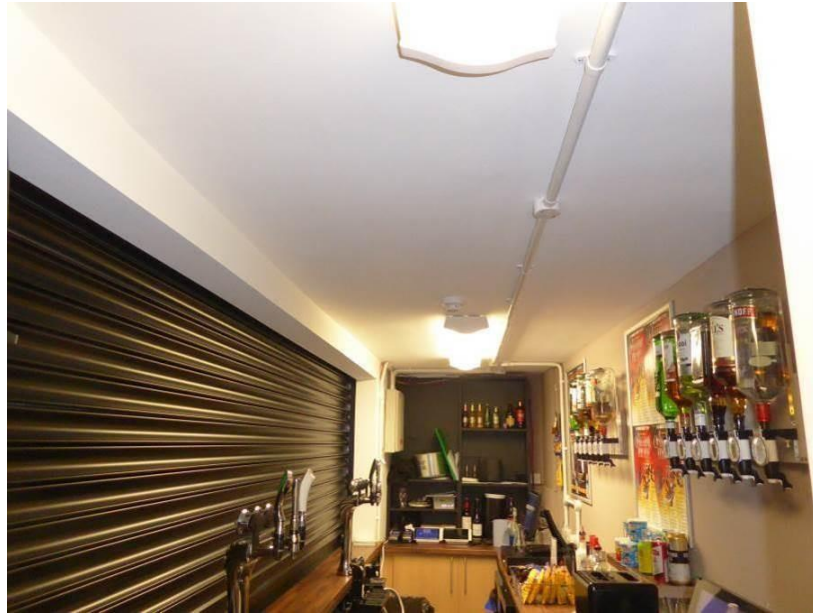
Photo 10 – Ceiling over the Servery.

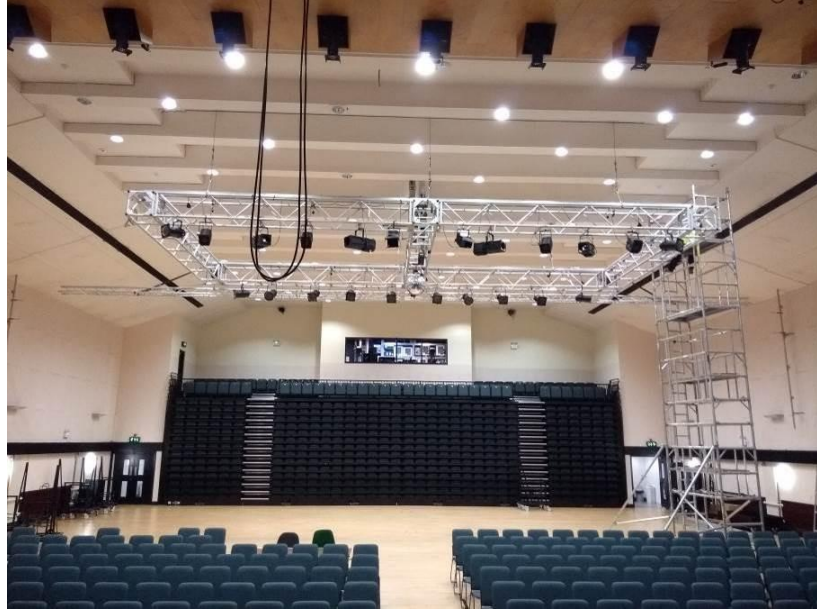
Photo 11 – Auditorium, retractable seating and lighting rig.

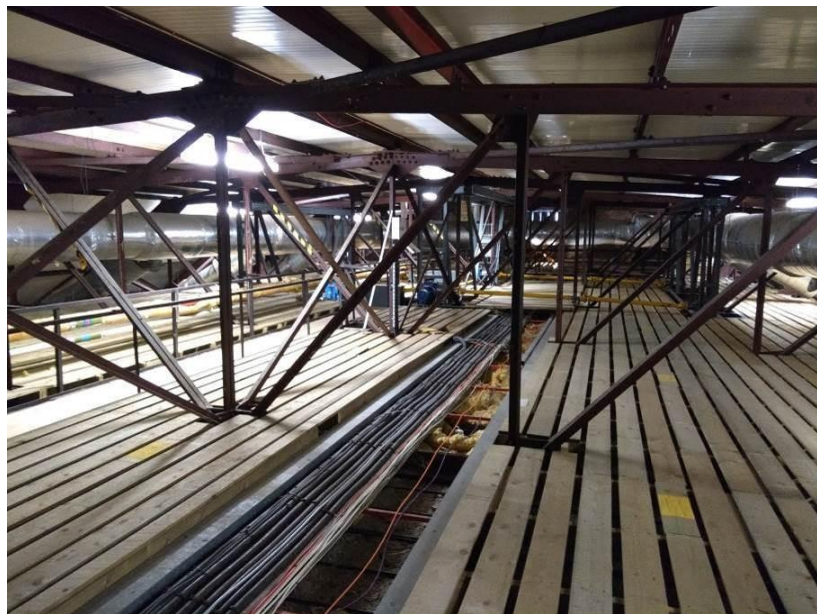
- 3.3.2.1 The ceiling was suspended from the roof structure, formed of steel trusses spanning over the auditorium, approximately 24 metres. The truss type was a flat vault gambrel truss. Spacing of the trusses was approximately 3.8m. See Appendix B for schematic drawings of the structure over the auditorium.

Photo 12 – Loft above Auditorium.

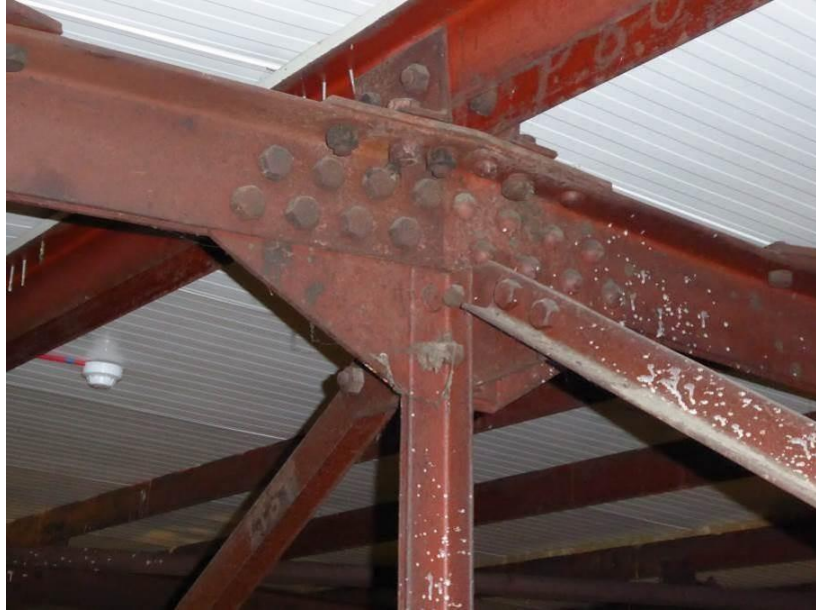
- 3.3.2.2 The connections in the trusses were formed with metal plates fixed to sections forming chords and struts with rivets and/or bolts. Presumably, trusses had been divided into sections for transport with the bolted connections assembled on site.

Photo 13 – Truss connection.

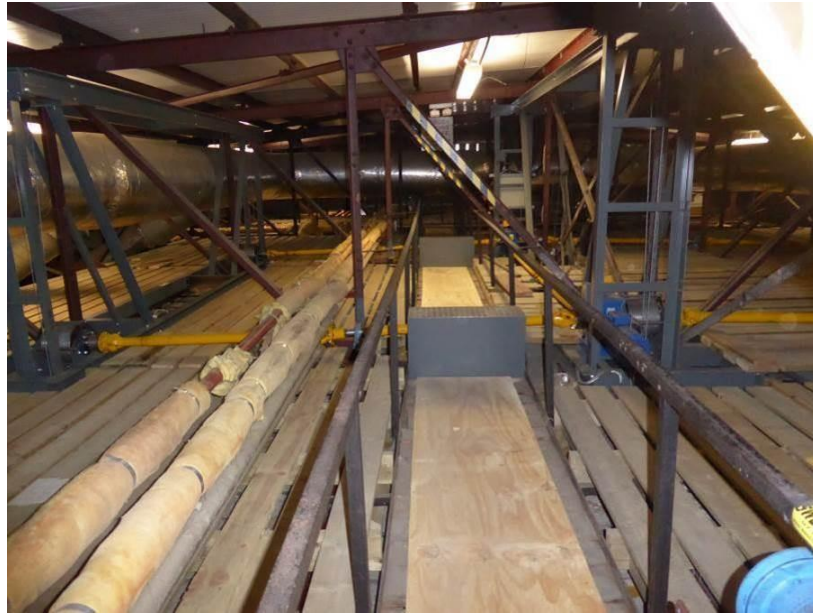
Photo 14 – Services in loft above Auditorium.

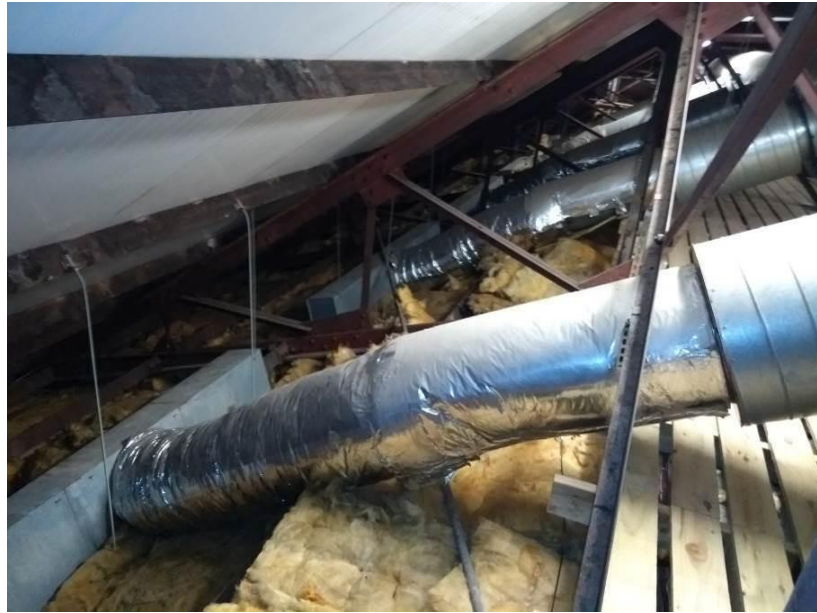
Photo 15 – Loft over vaulted ceiling -vent ducts, no timber decking for access.

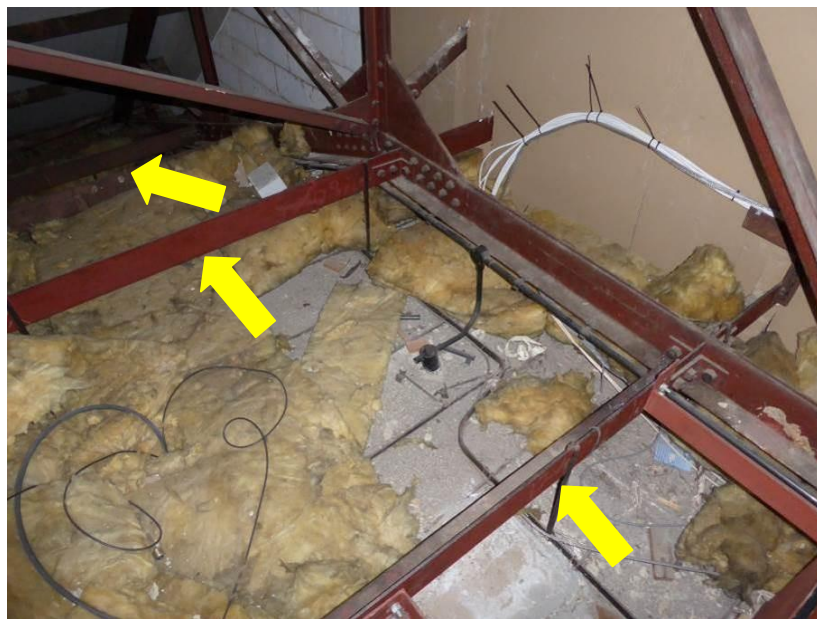
3.3.2.6 The substructure supporting the plastered ceiling was formed of steel angles, spanning between the roof trusses. The angles were fixed to the bottom chord of trusses at approximately 1.4m centres. The timber floor joists were bearing directly on the edge of the vertical arm of the angle. The floor structure was formed of 150mm deep by 45mm wide joists at 600mm centres and softwood floorboards placed with a gap between. The steel angles gave support to a flat ceiling over the central part of the Auditorium and vaulted ceilings on the sides, although the details differed depending on the area. The ceiling in the front part of the auditorium had been extensively altered, although the primary support system had not changed. Four types of ceilings were identified in the Auditorium area: high level ceiling, lowered ceiling, vaulted ceiling and stage ceiling. See following pages for details.

Photo 16 – Steel angles spanning between trusses and supporting the suspended ceiling.

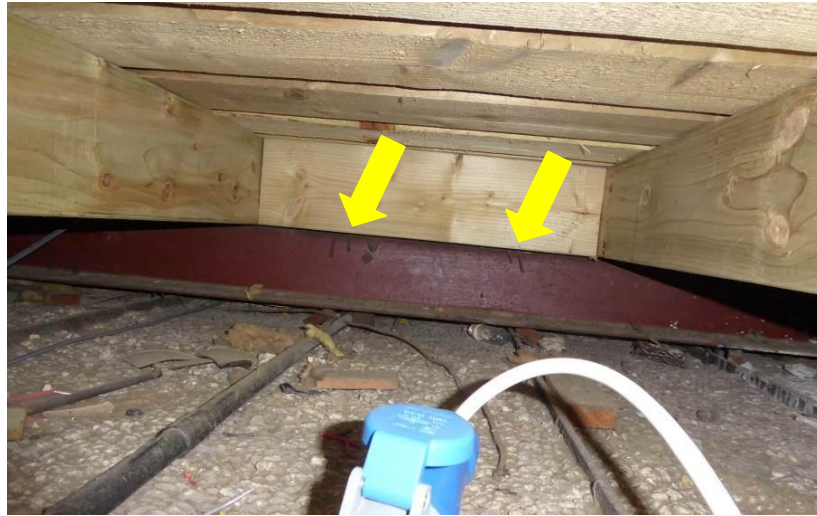
- 3.3.2.7 Part of the ceiling was fixed directly to the underside of the steel angles, acting as secondary beams. The substructure was formed of mild steel flat bars (presumably 18x6mm) at approximately 350mm centres, fixed to the steel angles with metal wire ties, hooked over the vertical arm of the angle.

Photo 17 – Metal wire ties hooked over the angle arm.

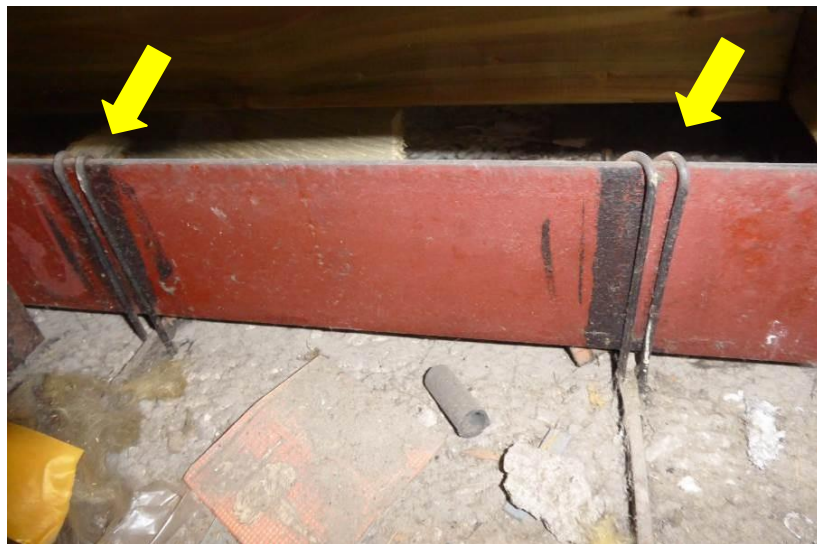
Photo 18 – Metal wire ties fixing flat bars to the angle.

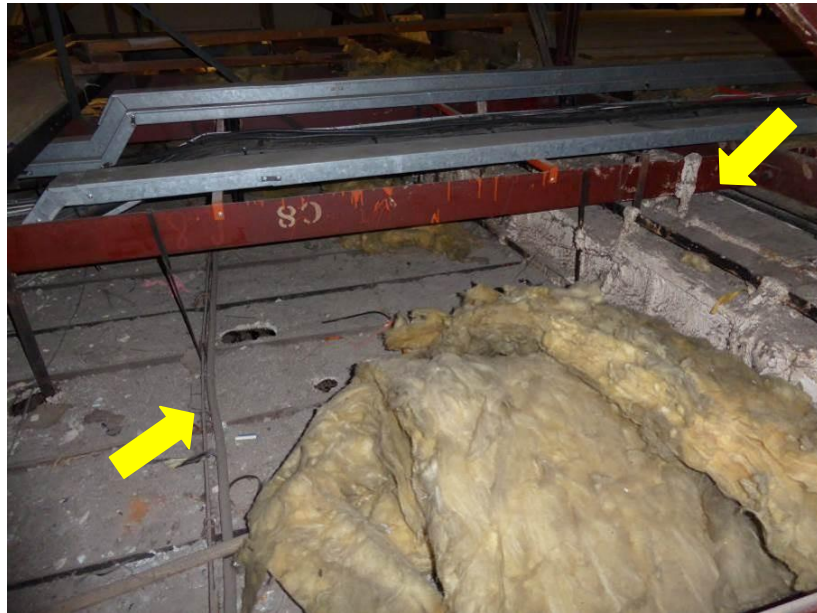
- 3.3.2.8 Part of the ceiling with solid work lowered below the supporting angles level, approximately 500mm (this distance may vary across the ceiling area). The substructure supporting the plastered ceiling was formed of mild steel flat bars placed in two layers and in orthogonal directions to each other. The bottom layer was 18x6mm flat bars placed at approximately 350mm centres. Top layer was formed of 30x6 flat bars at approximately 1.0m centres. The top layer was suspended off the steel angles (secondary beams) with ties formed of mild steel twisted flat bars (15x3mm). The ties were hooked over the vertical arm of the angle and over the flat bar. Metal wire was used generally to fix expanded metal lath to the bottom layer of the supporting structure, although hessian wadding ties had been noted in a few locations.

Photo 19 – Suspended ceiling, visible junction with high level ceiling.

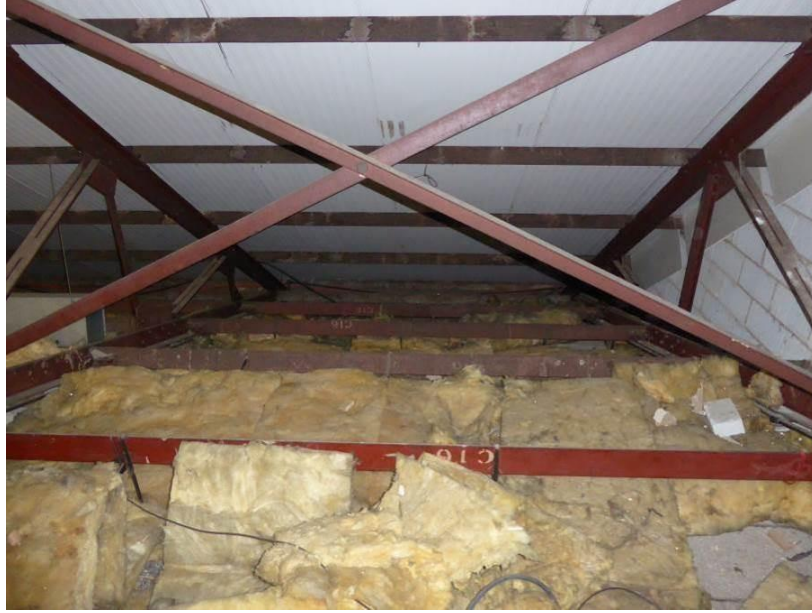
- 3.3.2.9 Part of the ceiling at the sides of the Auditorium, abutting the external walls. There was no good access to inspect the details of this ceiling construction from above. Considering the details of construction viewed in the loft, we assume that the construction of the vaulted ceiling is like the lowered ceiling, where the ties were fixed to the substructure and supporting angles (secondary beams) at closer centres.

Photo 20 – Void over vaulted ceiling.

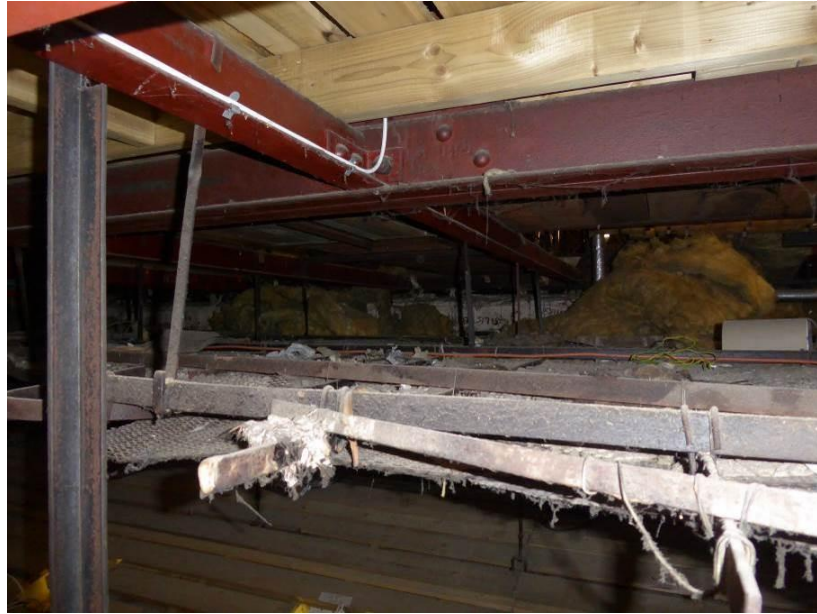
Photo 21 – Historic ceiling substructure.

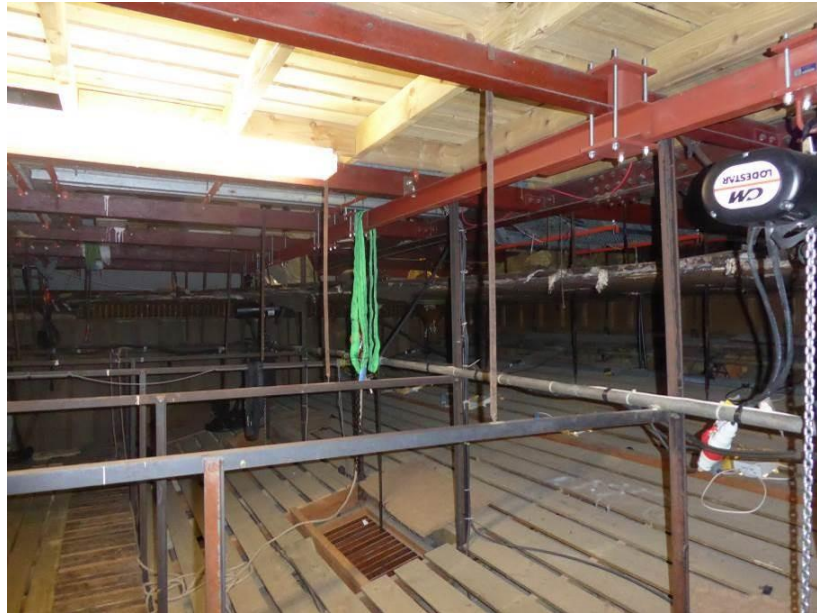
Photo 22 – Steel subframe supporting lighting rig.

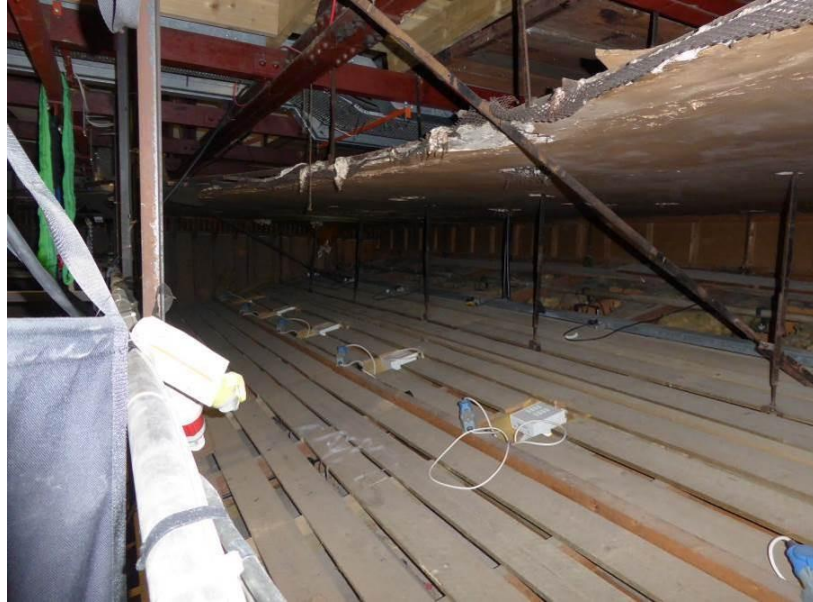
Photo 23 – Suspension of the lighting rig.

- 4.17 We also noted un-secured bolts in these connections, which increases stress on the surrounding ties and connections. In our opinion the suspension system used for the lighting rig requires a detailed assessment to confirm its viability.
- 4.18 The shear connections between angles forming suspension frame, secured with single bolts also need a detailed structural assessment. Secondary strap fixings may be required to minimise the risk of failure.

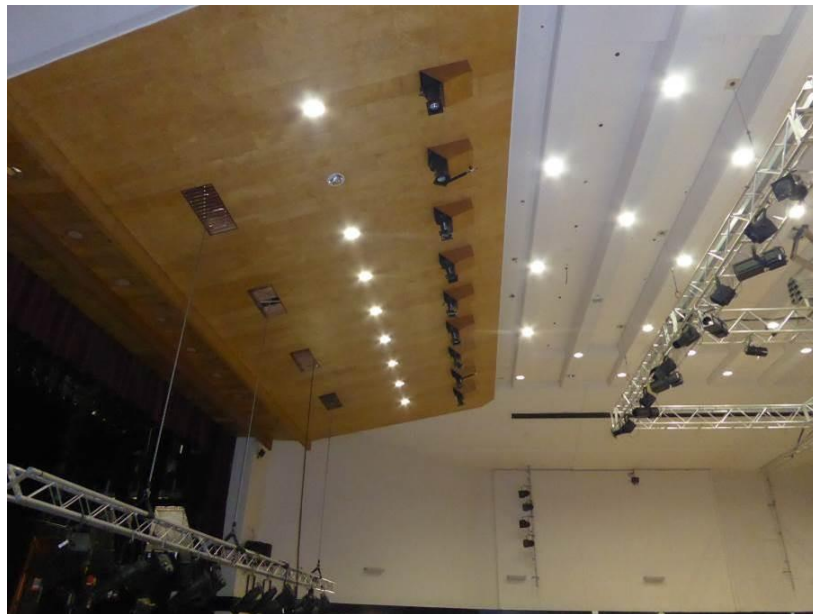
Photo 24 – Lighting rig, underside view.

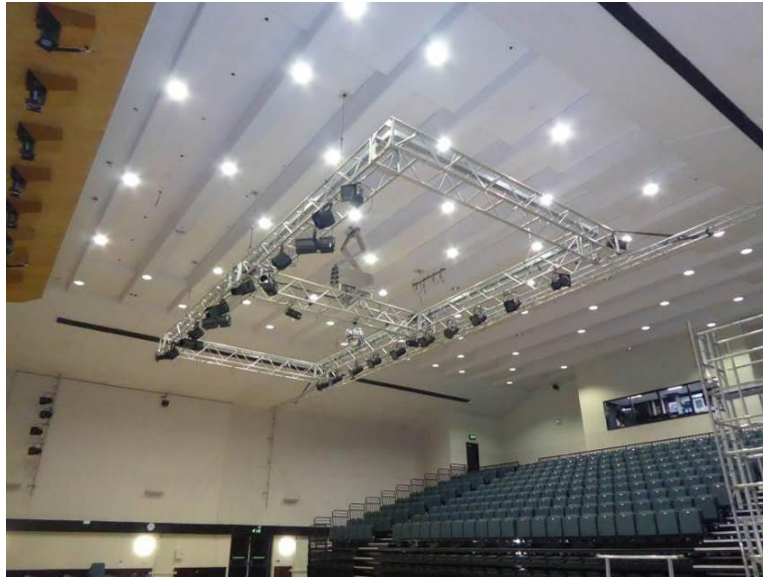
- 3.3.3.1 The ceiling was formed of solid work (cementitious mortar) applied to expanded metal lath. The lath was fixed to the ceiling's substructure with metal wire. The finish was indeterminate (possibly anhydrous plaster). The decorative plasterwork was cast fibrous plaster panels (hemihydrate plaster and hessian / timber reinforcement). The ceiling over the Auditorium comprised a large flat area in the centre and vaults on the sides, along the external walls. At the junction of the flat and vault ceilings a strip of ceiling was lowered and the step was generally finished with decorative Greek key panels.

Photo 25 – Ceiling over the Auditorium.

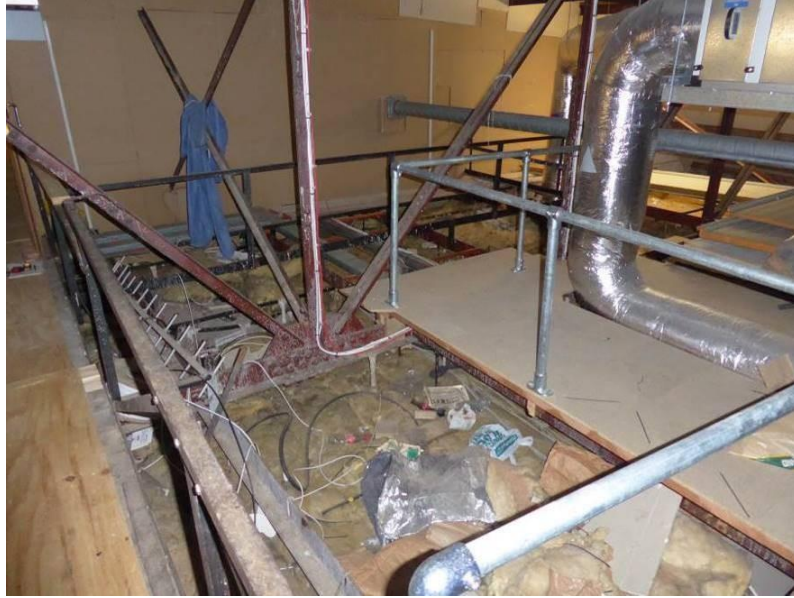
Photo 28 – Loft above Alamein Room.

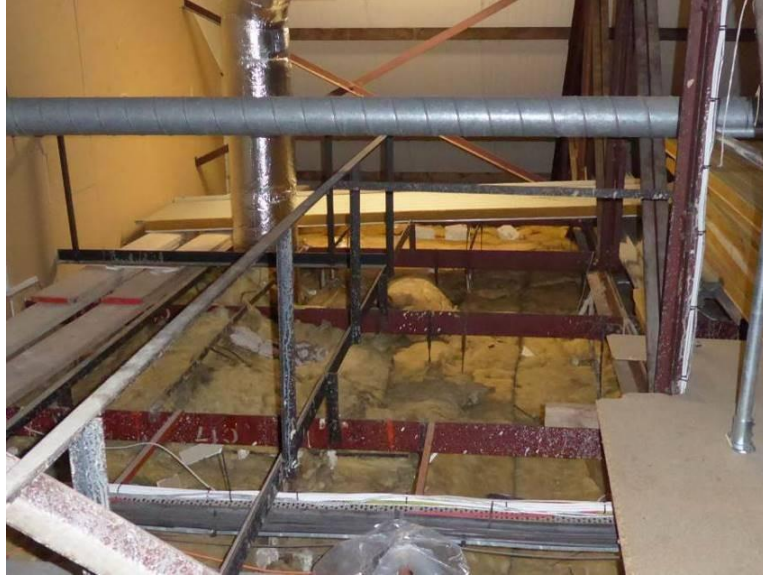
Photo 29 – Ceiling above Alamein Room.

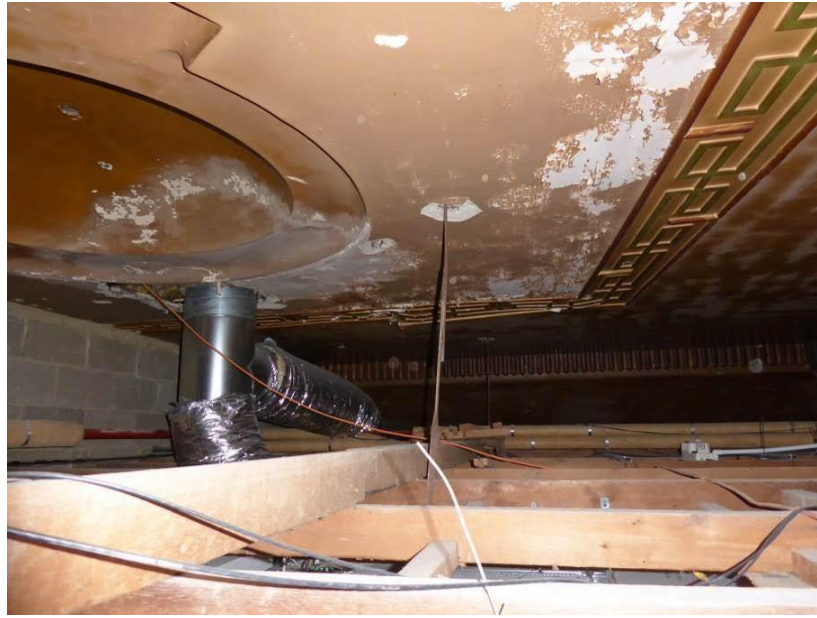
3.4.3.2 Numerous apertures were formed within the existing ceiling, where hangers had been installed to support the timber subframe for the lightweight, tiled suspended ceiling. Openings for ventilation ducts had also been cut in the historic suspended ceiling.

Photo 32 – The underside of suspended ceiling over Alamein Room.

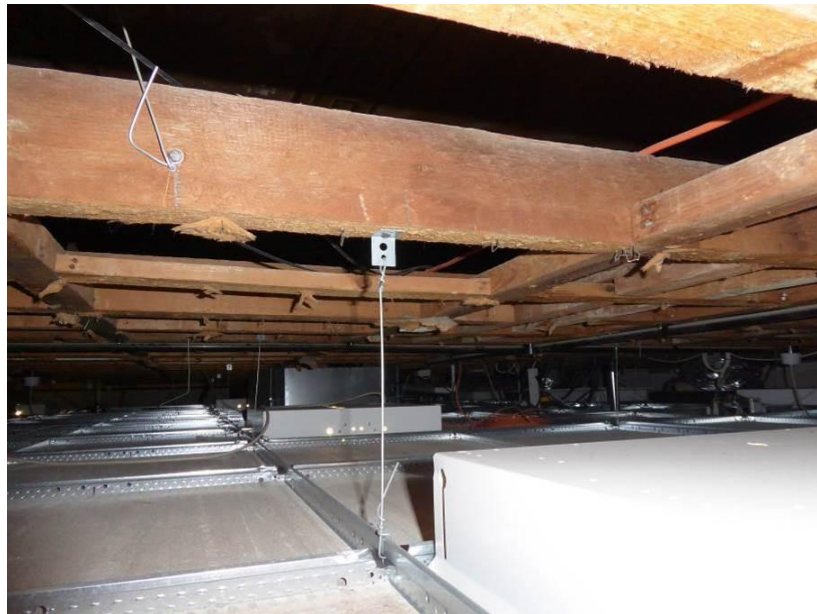
Photo 33 – Tiled suspended ceiling and timber frame over Alamein Room.

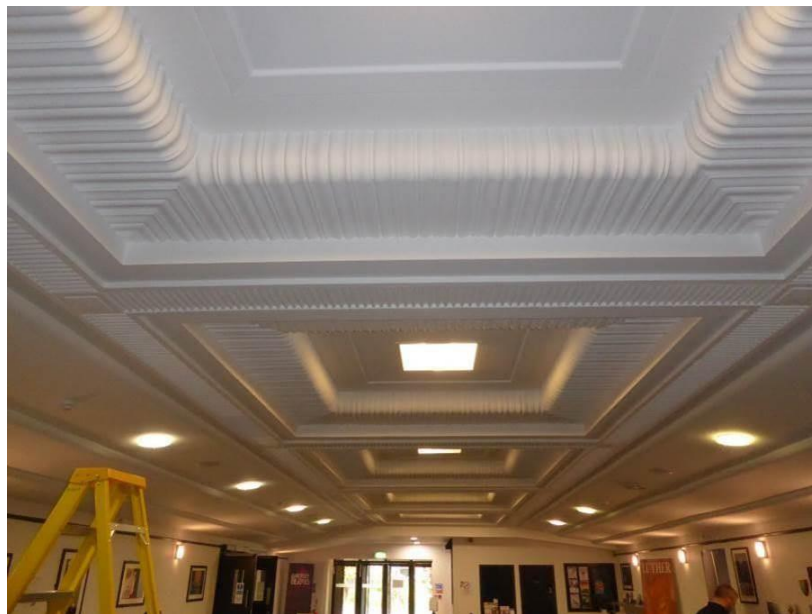
Photograph A1.8 – Foyer ceiling general view.

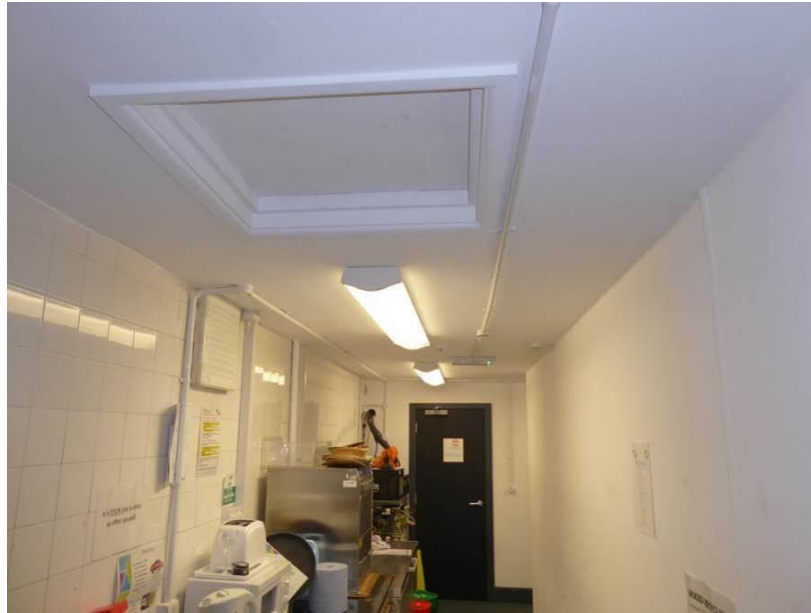
Photograph A1.9 – Kitchen ceiling.

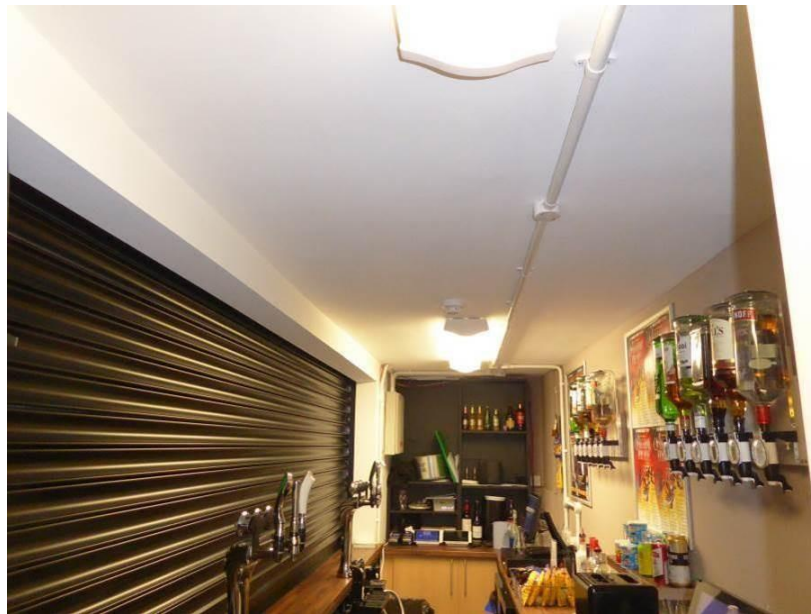
Photograph A1.10 – Kitchen servery ceiling.

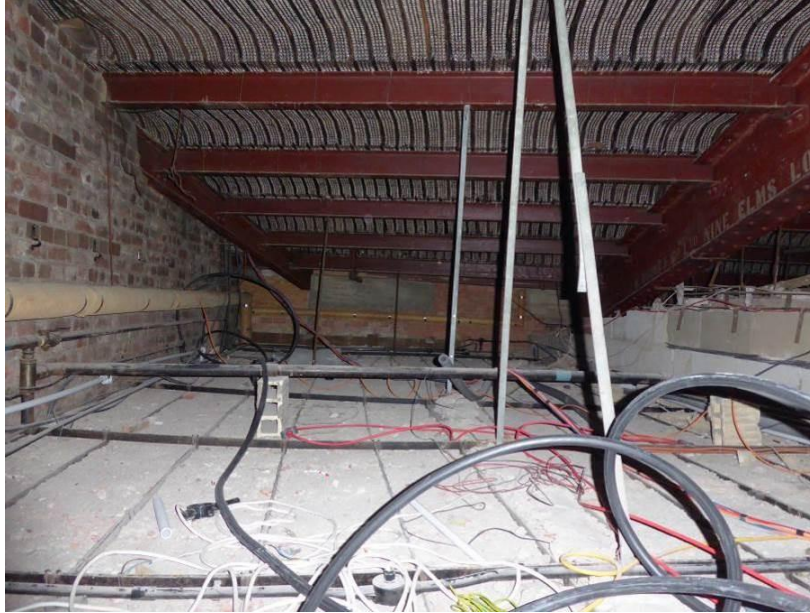
Photograph A1.13 – Ceiling void over Kitchen / Servery.

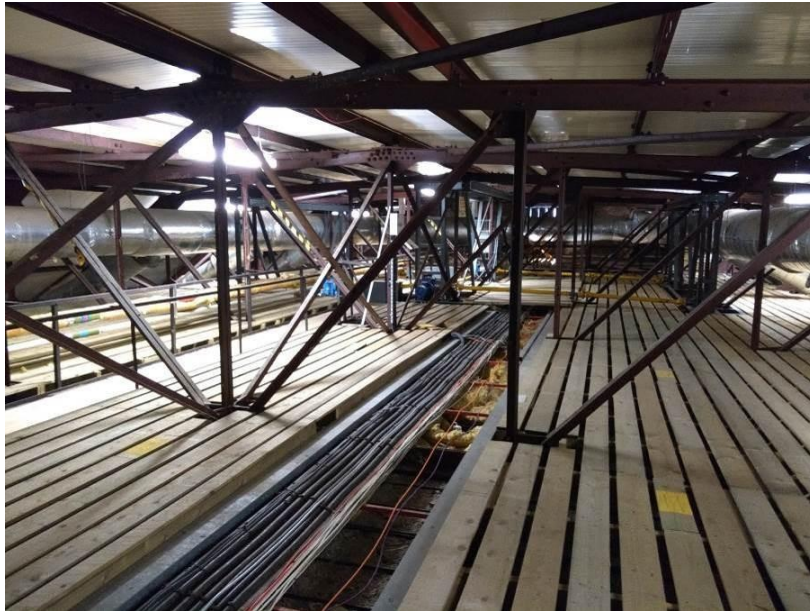
Photograph A1.14 – Ceiling void over Foyer.

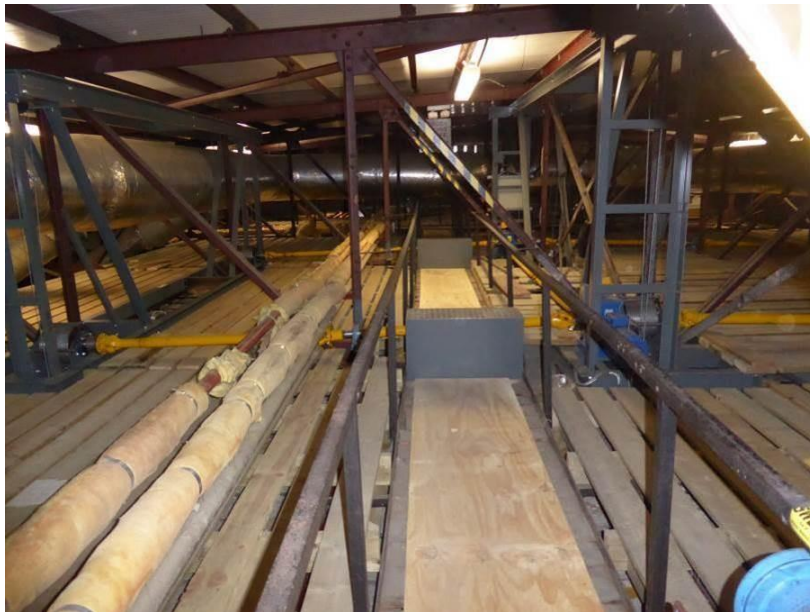
Photograph A1.15 – Loft over auditorium, general view.

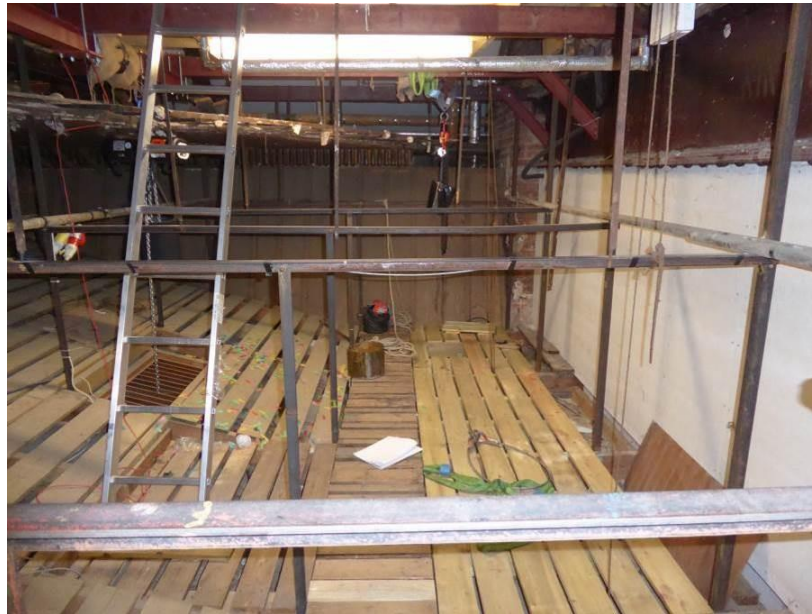
Photograph A1.16 – Lighting rig hoist over auditorium.

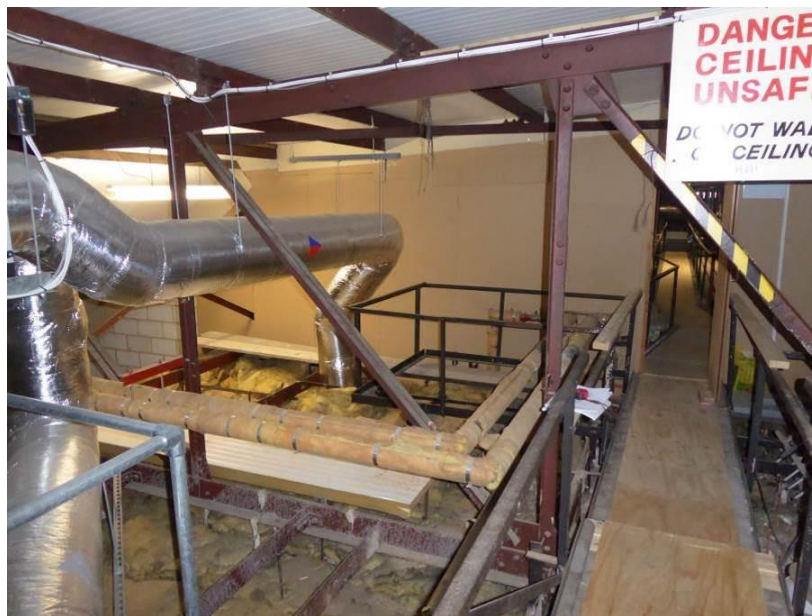
Photograph A1.17 – Lighting platform over Auditorium, next to stage.

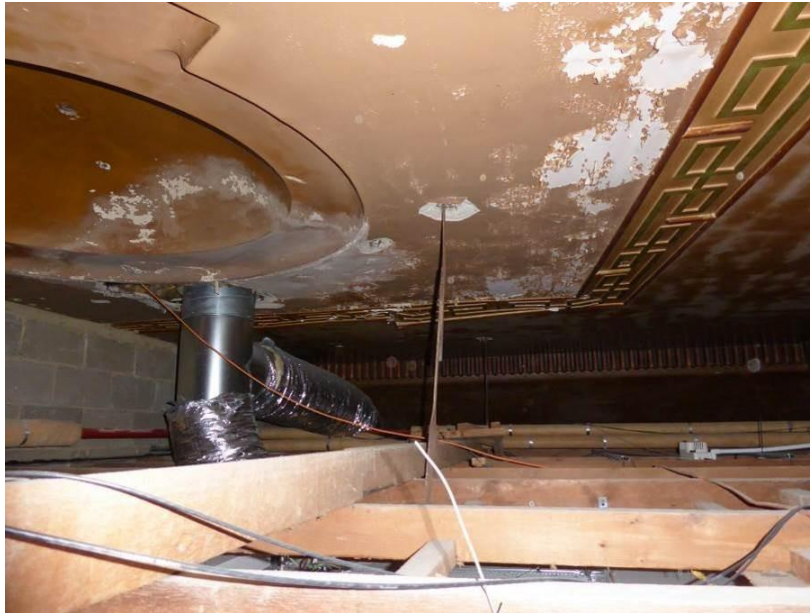
Photograph A1.18 – Loft over Alamein Room.

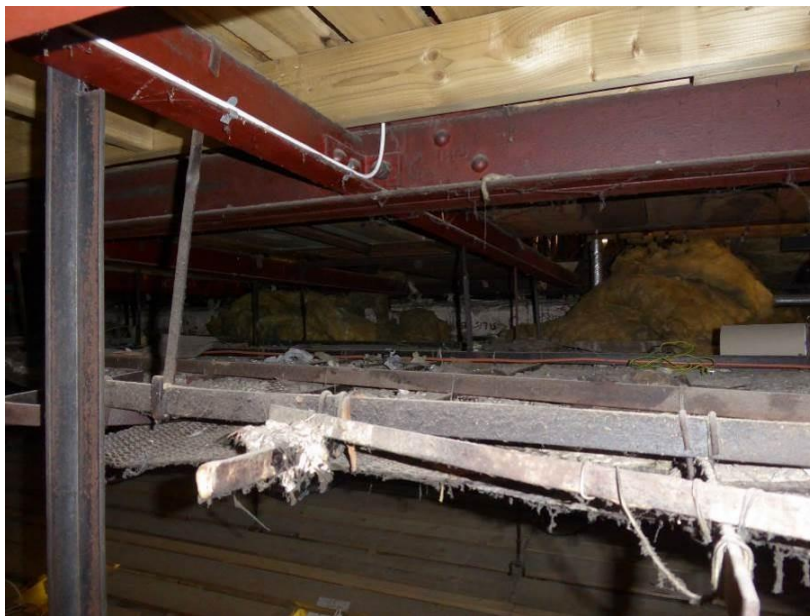
Photograph A1.19 – Original ceiling above in the Alamein Room.

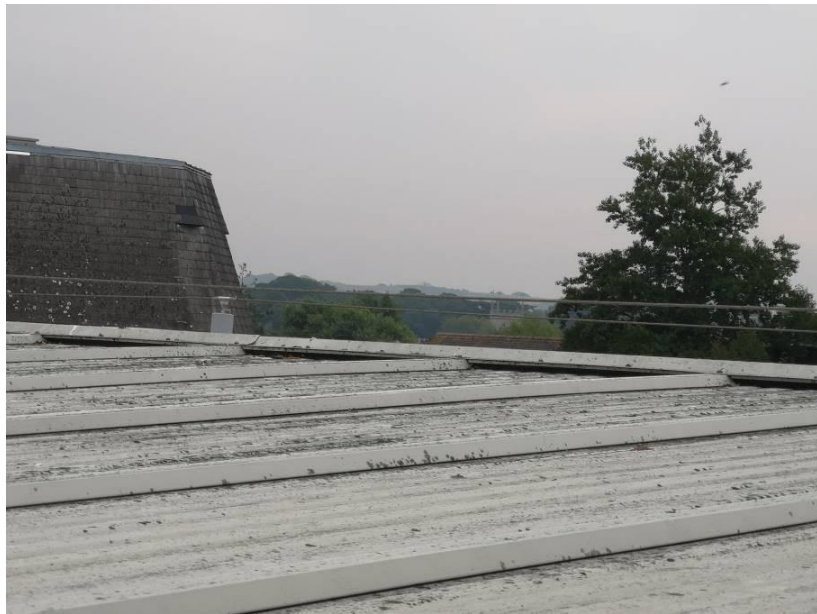
Photograph A2.3 – West elevation, look north along ridge line to main auditorium roof – note the missing ridge flashing.

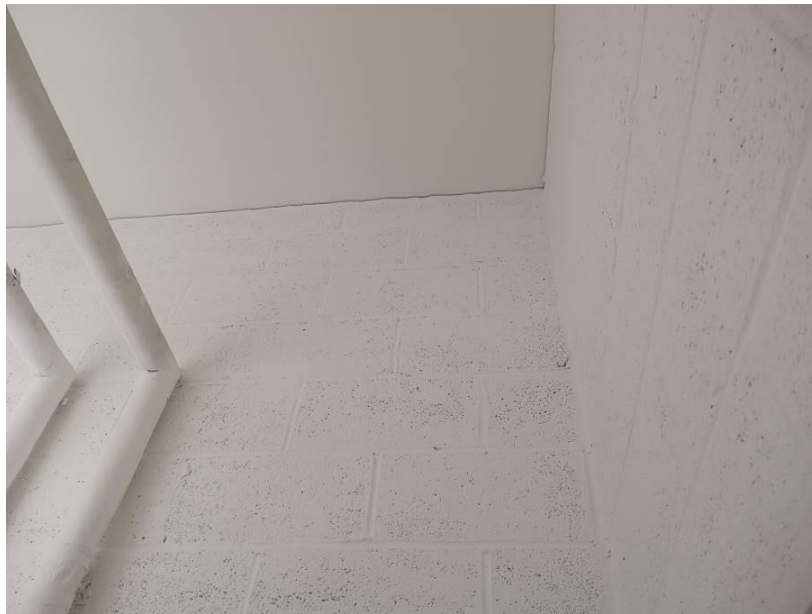
Photograph A2.7 – Loft side of high-level roof – showing numerous openings.

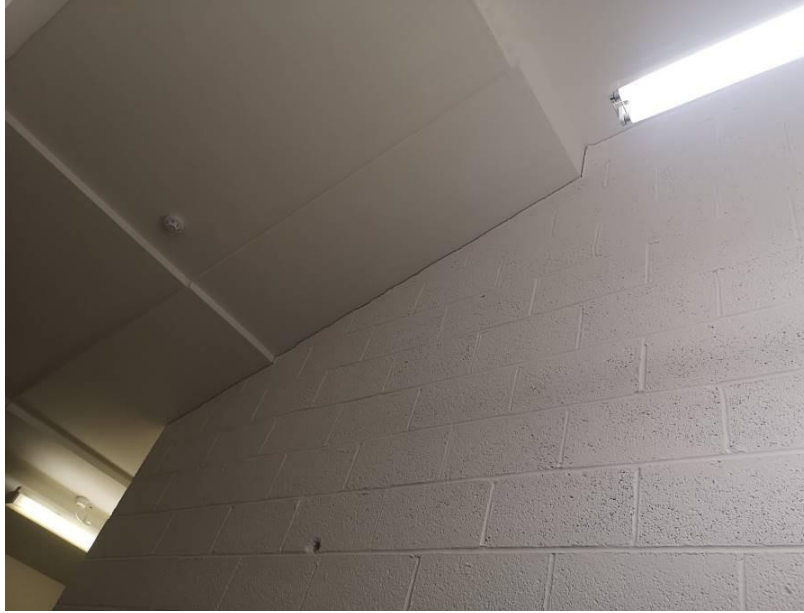
Photograph A2.8 – Gap at top of recently painted wall to SpireFM offices.

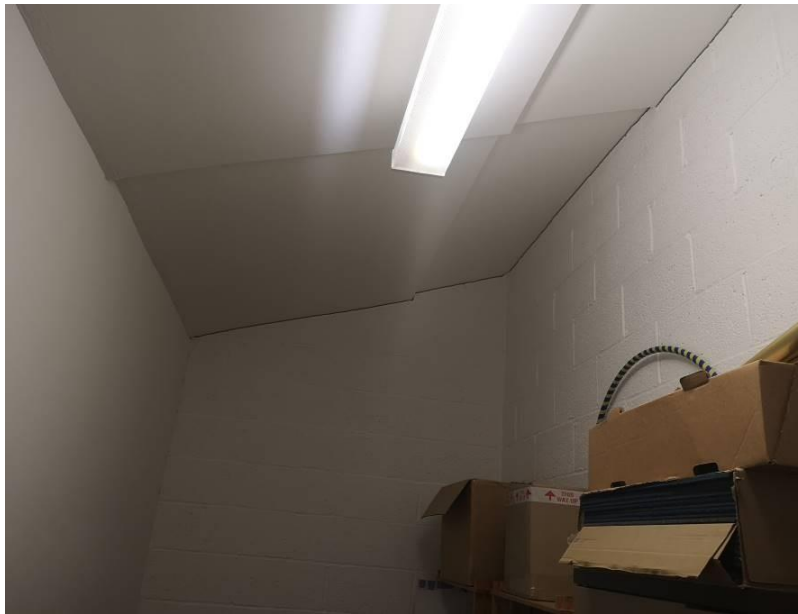
Photograph A2.9 – Gap at top of recently painted wall to SpireFM offices.

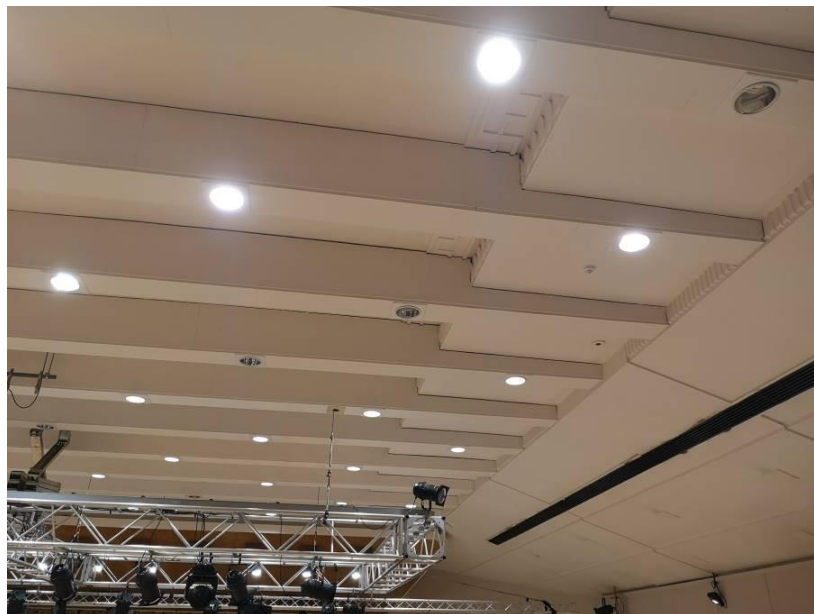
Photograph A3.1 – Main auditorium ceiling on third visit.
