**City Hall Salisbury
Malthouse Lane, Salisbury
SP2 7TU, UK**

**Suspended Plaster Ceilings
Inspection**

Prepared for
Kier Workplace Services

September 2020

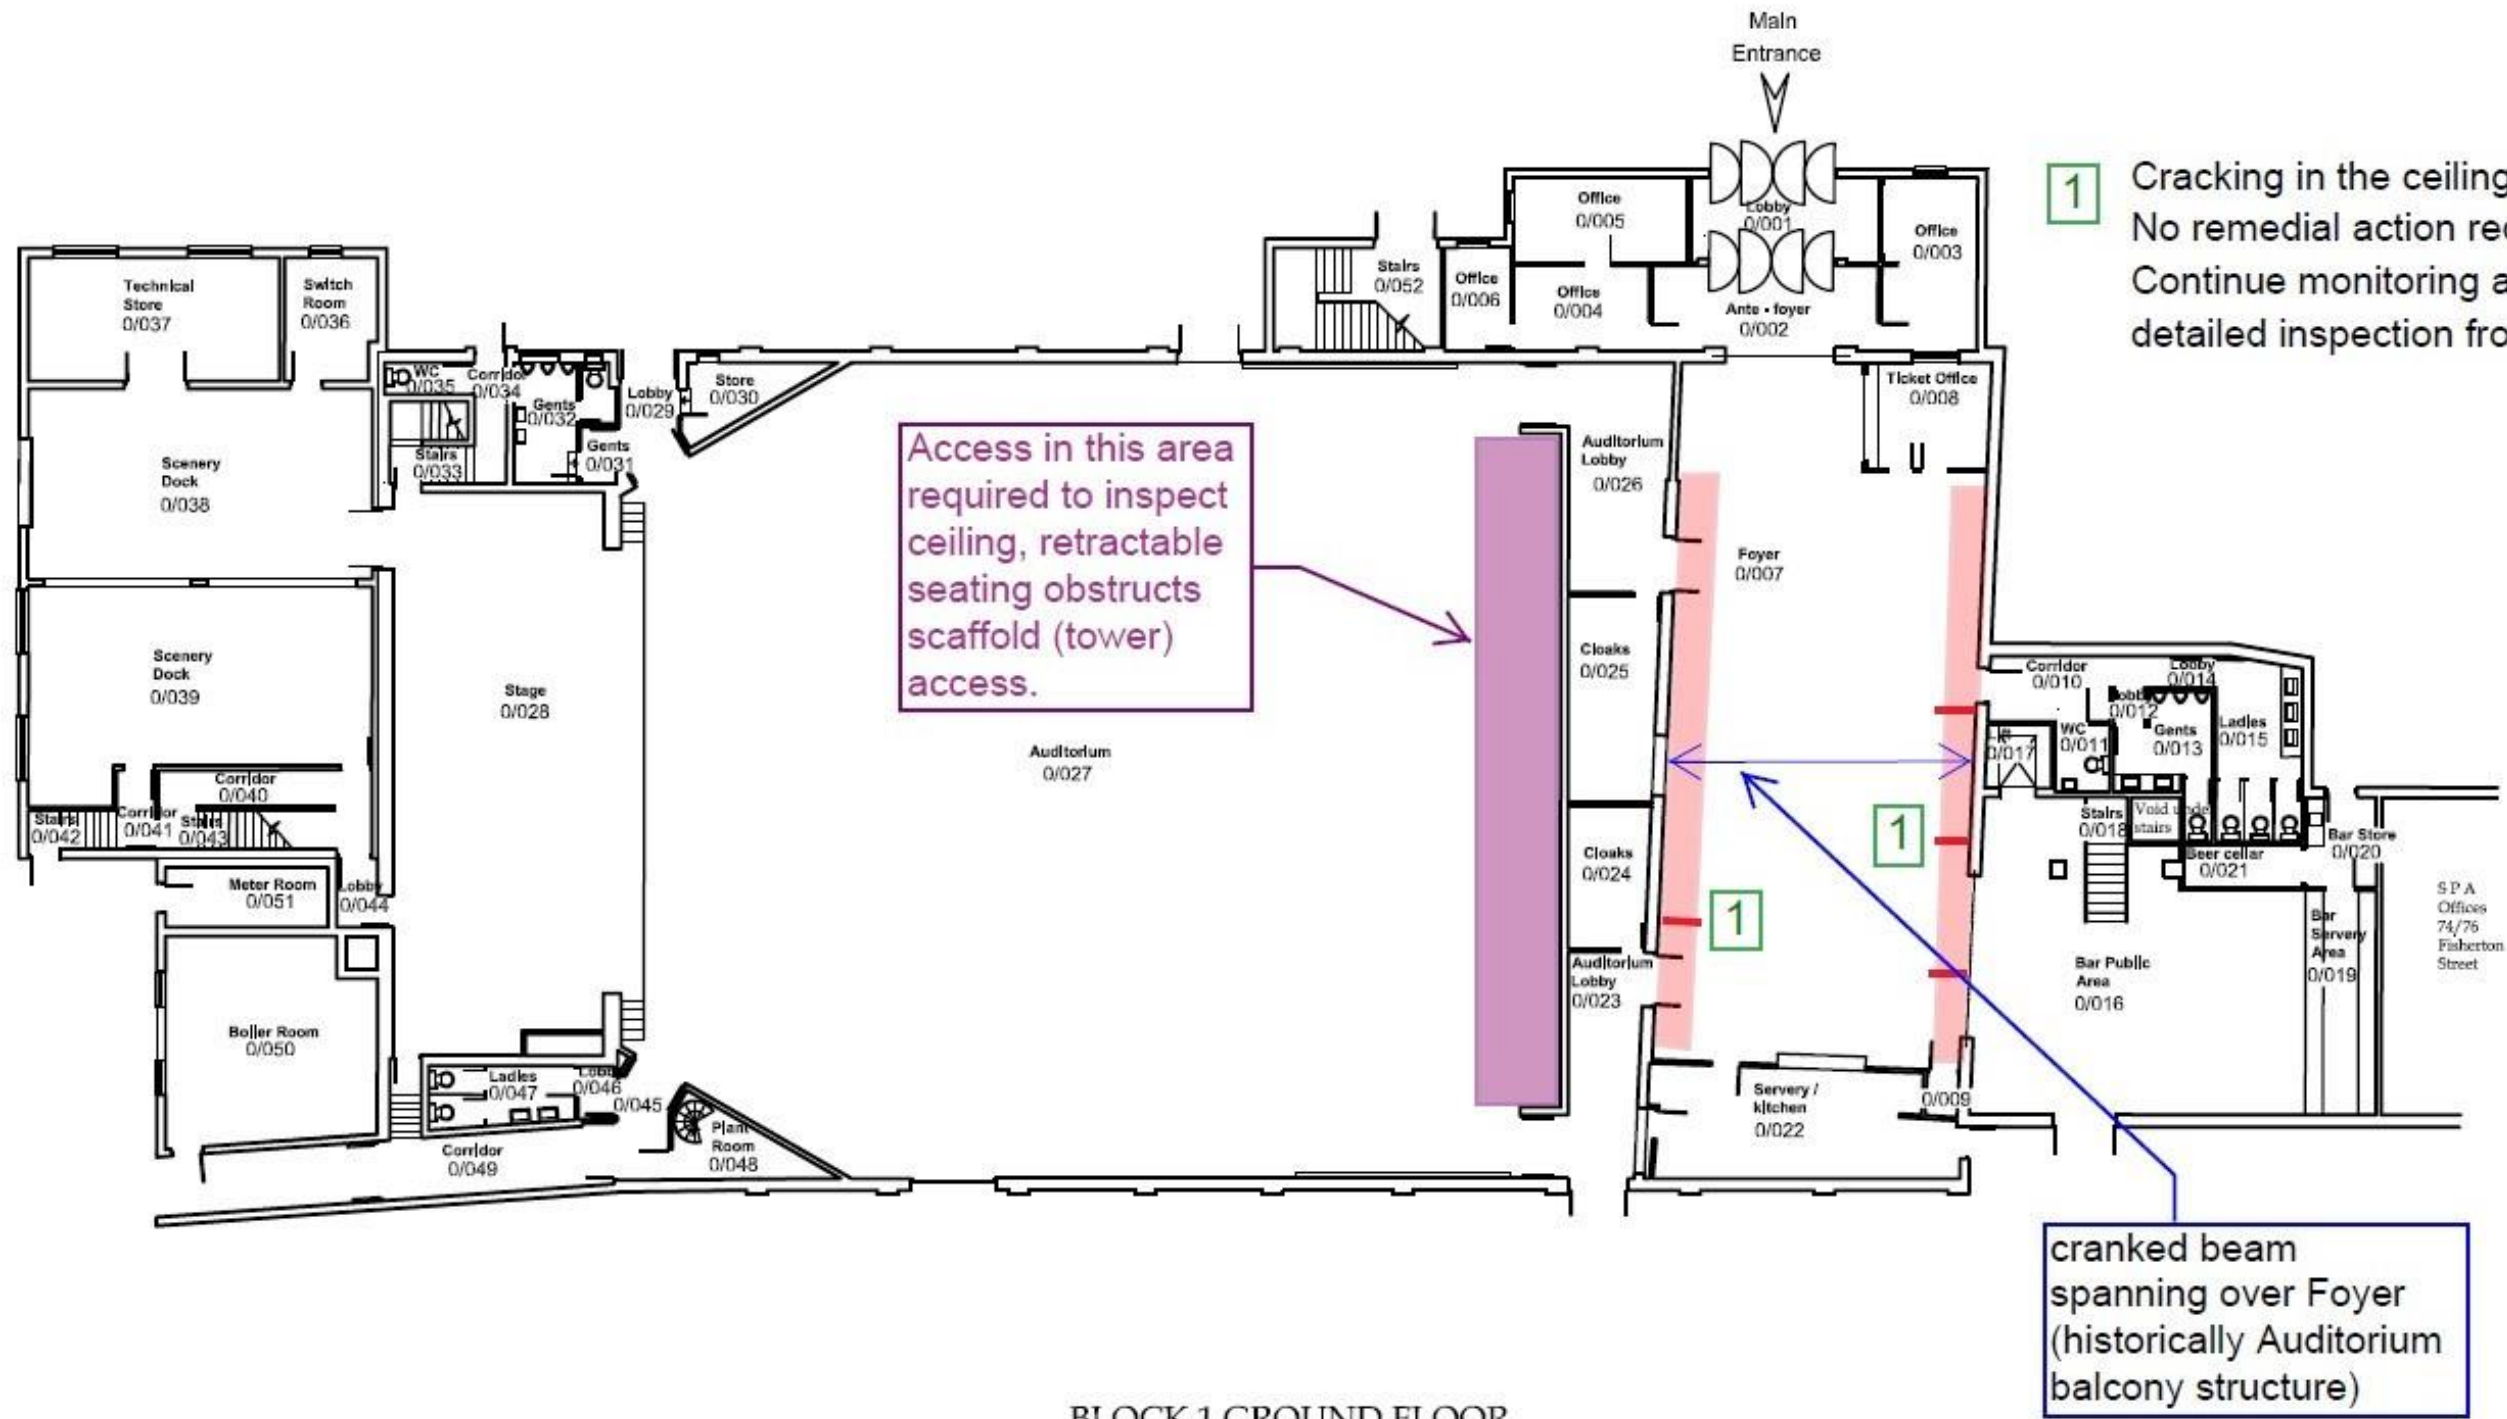
STRUCTURES AND DEFECTS CHART – GROUND FLOOR

- 1 Cracking on right-hand and left-hand side of the stage, not a structural issue but requiring repair and monitoring.
- 2 Cracking in Greek key decorative panels. Requires assessment and remedial repairs within 9 months to prevent failure.
- 3 Cracking in ceiling, immediate access required to assess nature of cracking and condition of the suspended ceiling.
- 4 Suspended plastered ceiling - investigate potential damage due to water ingress. Remove all loose / abraded / broken pieces of plasterwork within 9 months to prevent failure.

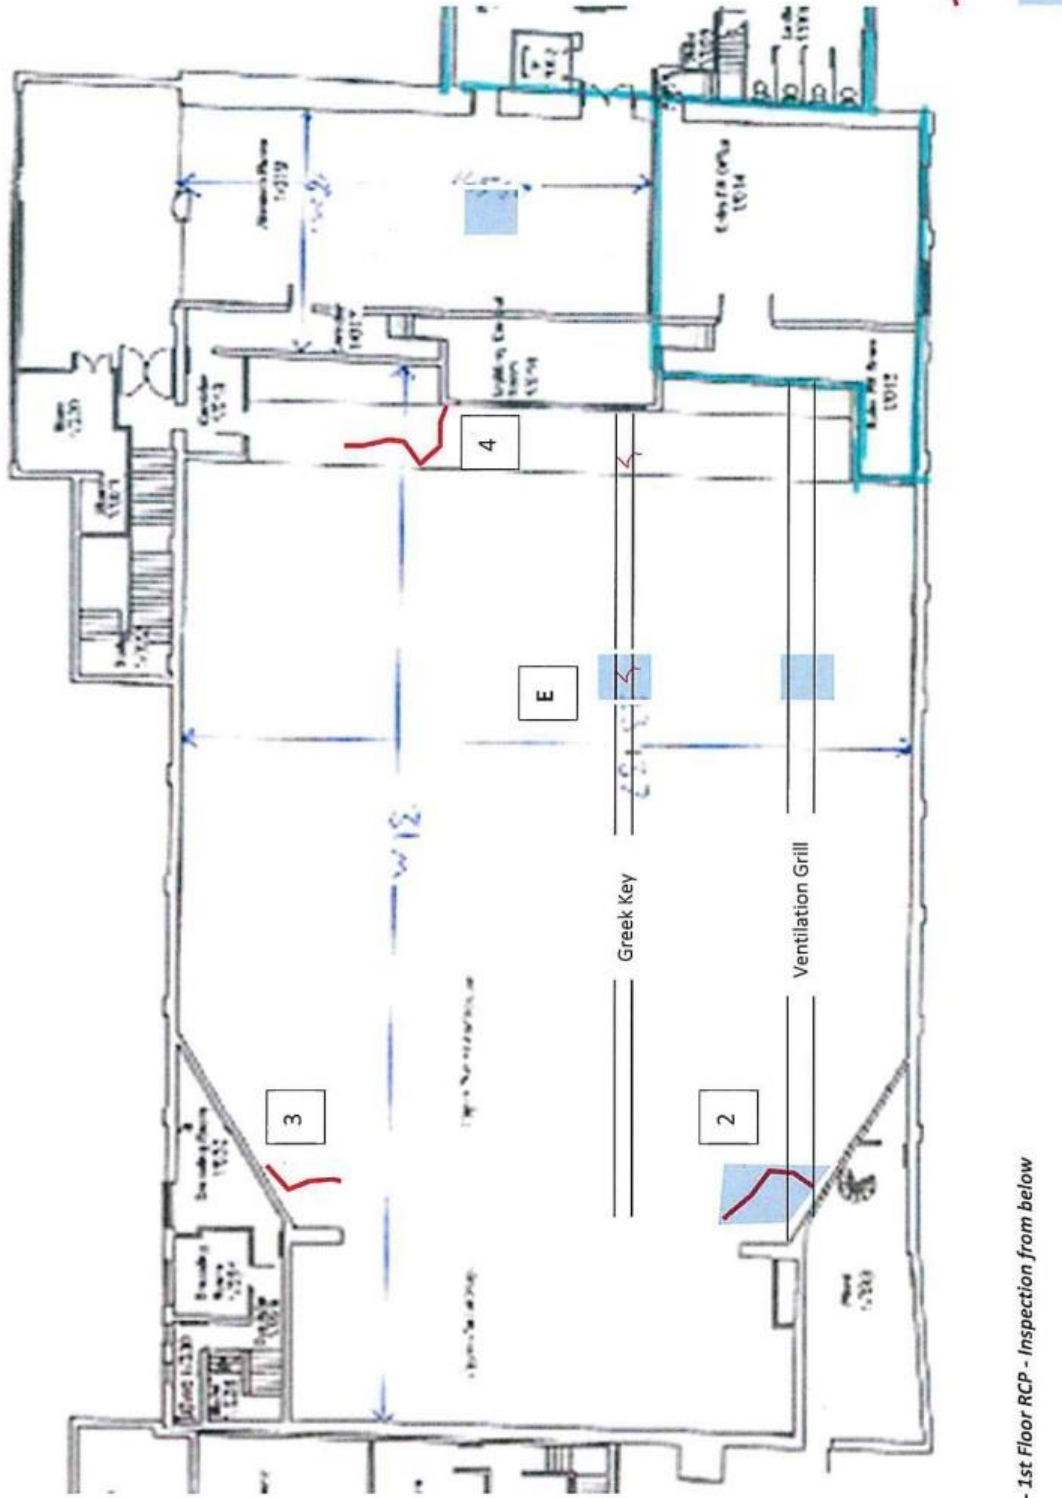
Figure 1 - 1st Floor RCP - Inspection from below

Cracking	Projecting parts of the Greek key between and adjacent to cracking are loose. Remove debris from above these plaster casts. Loose/cracked areas cut out and made good.		Yellow
2

Cracking	Currently sound however, visual appearance undermines this and so it may be desirable to make good this crack. Continue to monitor crack.		Green
3

Cracking	Ditto		Green
4

Cracking	Access required to inspect the plasterwork and establish if this area is unsound/live.		Red

5	 	Cracking	Continue to monitor cracking	 
---	---	----------	------------------------------	--

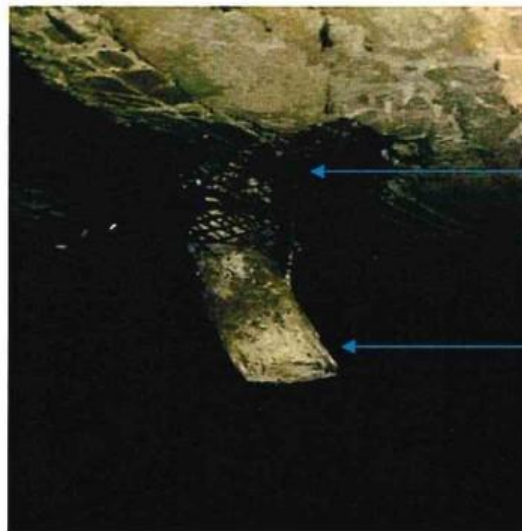
Figure 3 - Wire & Wad Fixing

However, or at least in a single instance, we were able to illustrate that a wad has been reinforced.

Plaster wad

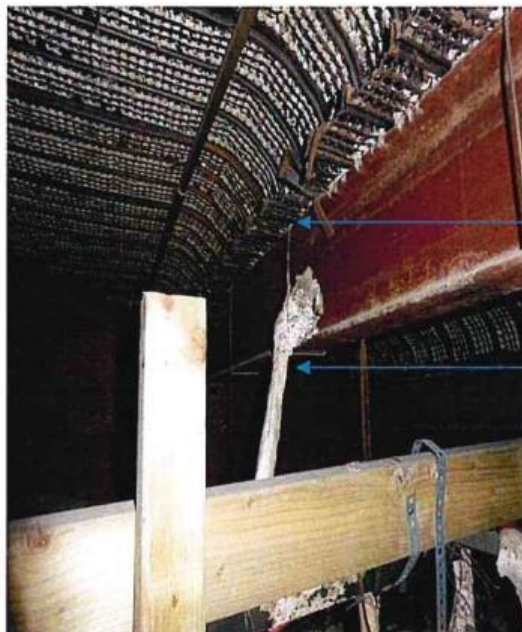
Further instances of clip wadding to tying wire was also observed.

Mild steel tying wire

Clip wad

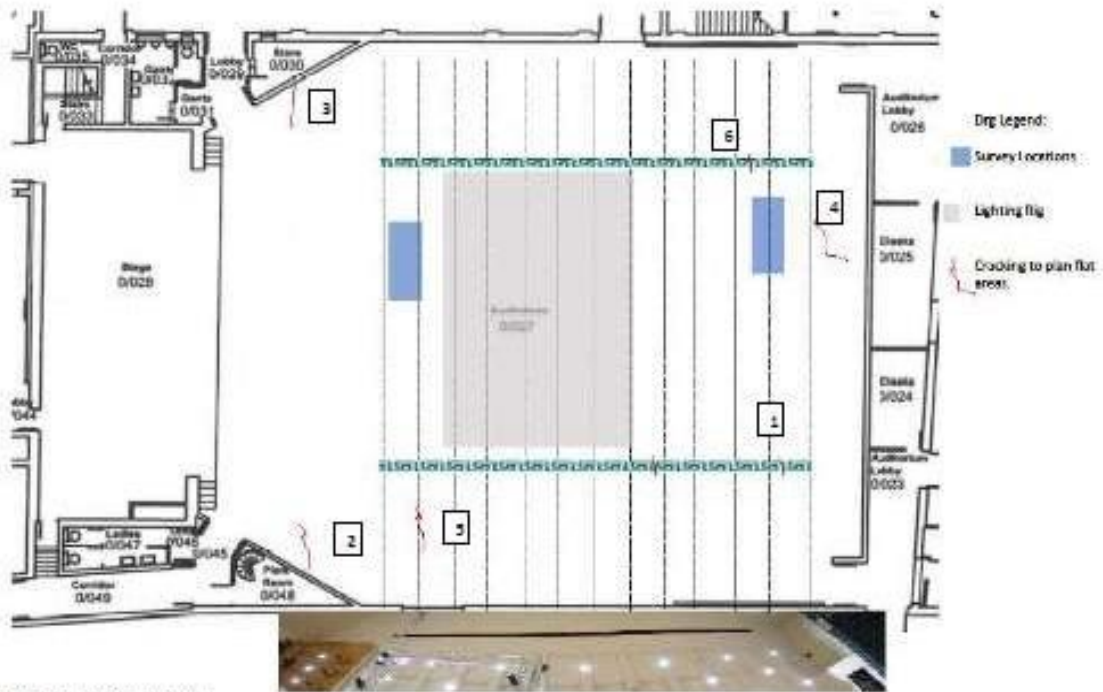
Figure 1 - 1st floor NCP inspection from below

Visual inspection from nearest to the stage³ revealed a p/b (plasterboard) ceiling, occurring between the light troughs in this single location. It was unclear from the survey location the purpose of this secondary ceiling finish and whether it was suspended below the existing ceiling or if the ceiling had been removed from above.

Second survey location was firm to applied pressure and typical of the conditions when surveyed dated 24th June 2019.

Generally, except for several additional cracks identified, previously identified cracks were in a like condition.

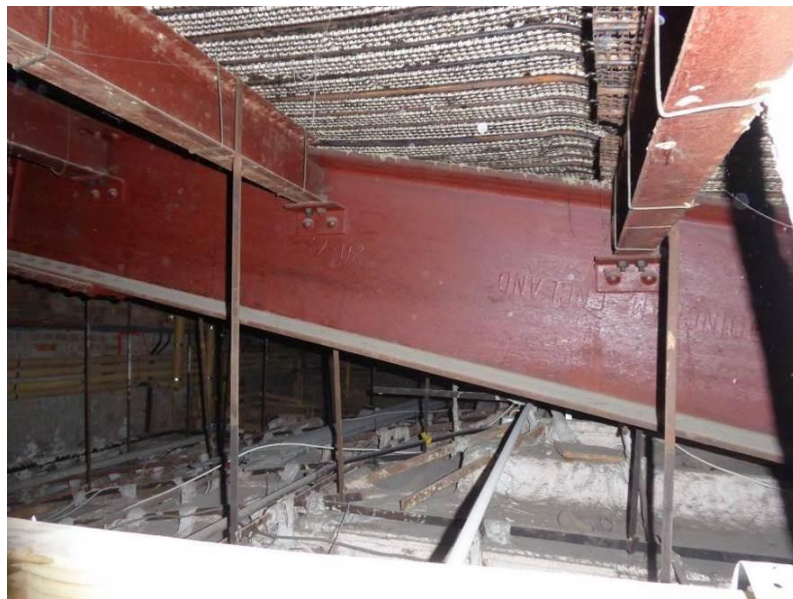
The ceiling was suspended from the floor structure, originally forming the auditorium balcony. The structure was formed of deep cranked primary steel beams and secondary beams spanning between, and supporting the stepped floor. The floor was presumably concrete cast on metal lath, tied to the steel beams with metal wire.

Photo 1 – Ceiling void above Foyer.

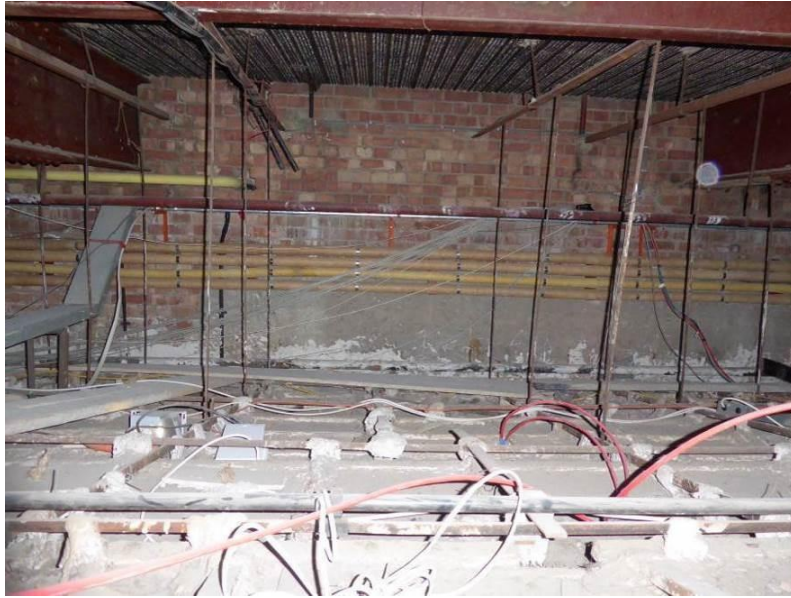
The ceiling structure was suspended with flat, twisted bars. These bars were hooked over the top flange off the secondary beams or fixed to the angles spanning between the secondary beam and masonry wall. There was no access to measure size and gauge of the ties. Beside flat bar ties, hessian wadding ties had been used to suspend the ceiling (ceiling over the part of Foyer abutting Auditorium). It was likely that the hessian wadding ties fixed to the secondary steel beams had metal wire reinforcement.

Photo 2 – Ceiling void above Foyer.

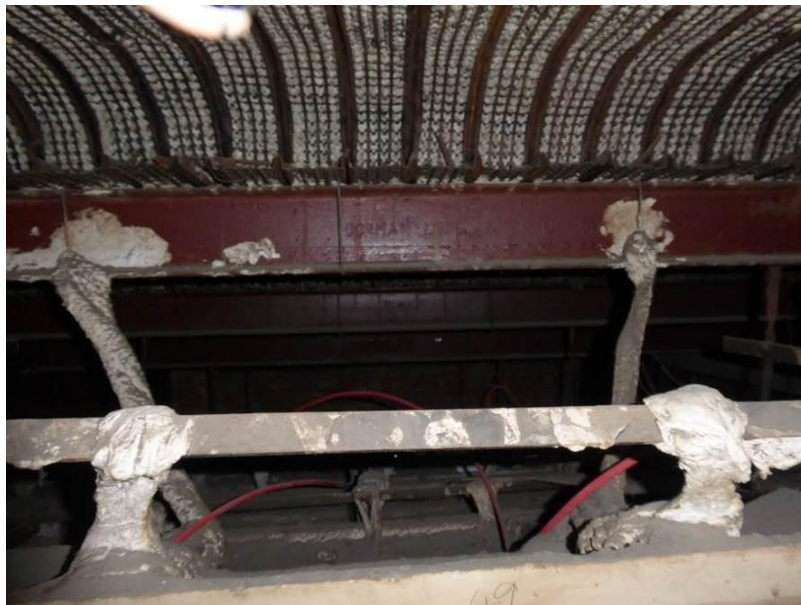
The substructure supporting the plastered ceiling was formed of mild steel flat bars placed in two layers and in orthogonal directions. Top layer was formed of 30x6mm flat bars, it was not possible to measure the exact size of the bottom layer flat bars but considering the construction of the ceiling in other areas they were likely to be 18x6mm.

Photo 3 – Hessian wadding ties supporting the suspended ceiling.

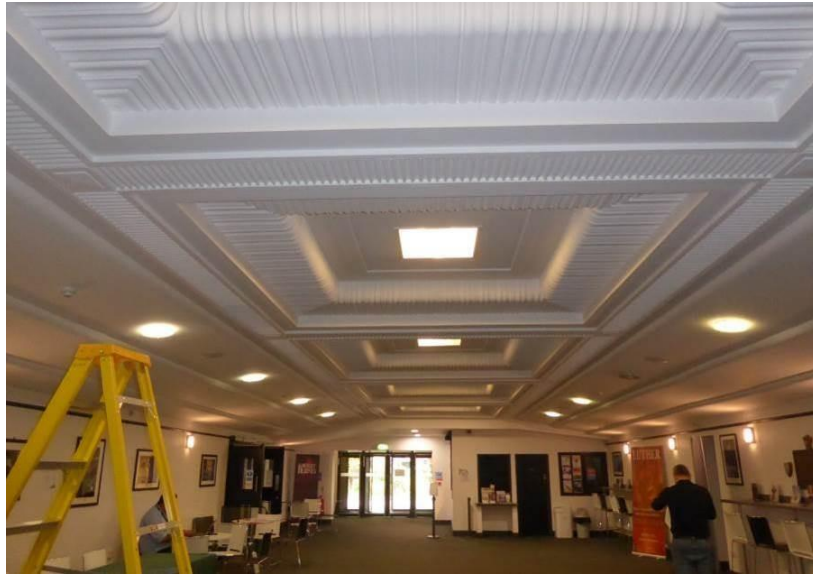
Photo 4 – The suspended ceiling over Foyer.

Visually the ceiling plane had slight undulations, however the plain and decorative areas were sound and firm when pressure was applied. Cracking was seen intermittently, mostly along the South external wall and at approximate 4.0m centres. The cracking was below the painted surface and so was not active / live.

- 8.1 In the Foyer area, provide safe access to the void above ceiling, to facilitate inspection of the whole area and assess full condition of the ceiling's substructure, cast plaster panel attachments and plaster key attachments in the cracked areas.

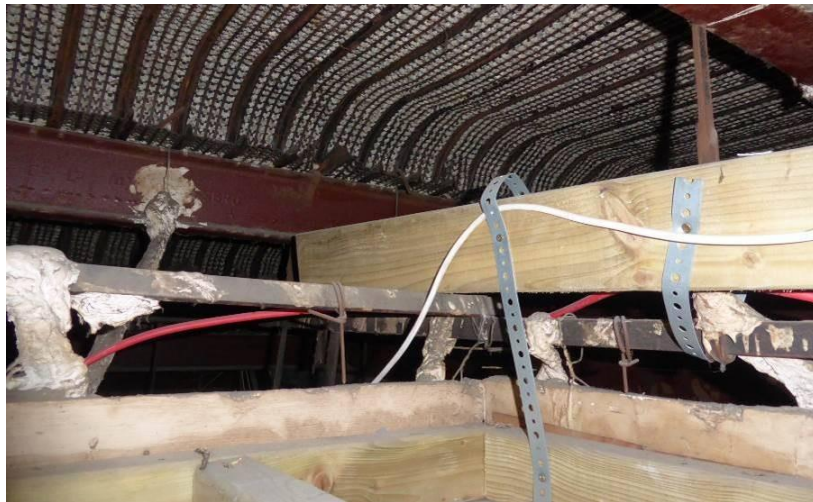
Photo 5 – Timber frame around light fitting, over the coffer.

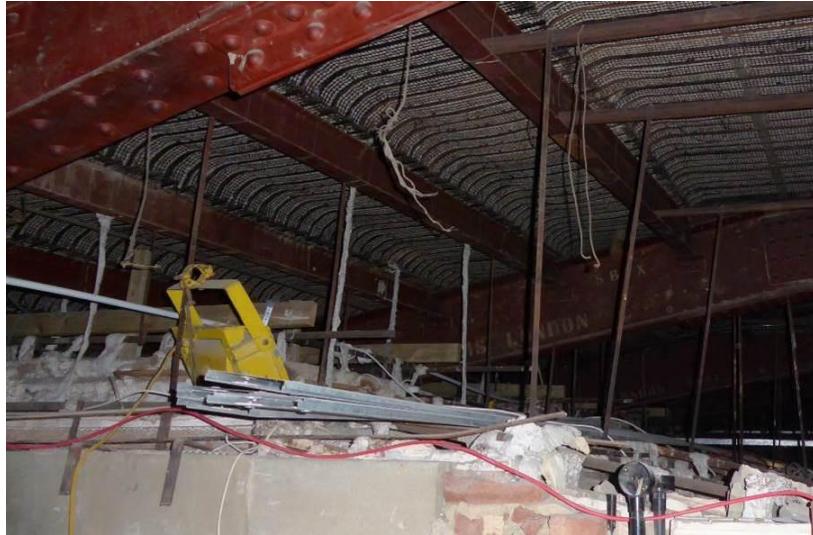
Photo 6 – Void over Foyer ceiling, timber frames over the coffers.

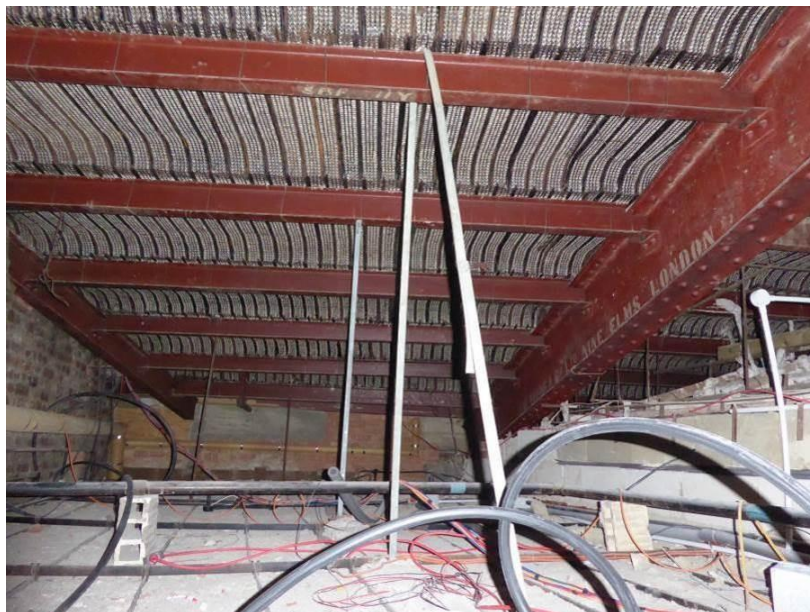
The ceiling structure was suspended with a few ties only. These ties were galvanized flat bars and they seemed to be modern alteration of the ceiling's structure. No hessian ties were observed in this area.

Photo 8 – ceiling void above Kitchen / Servery.

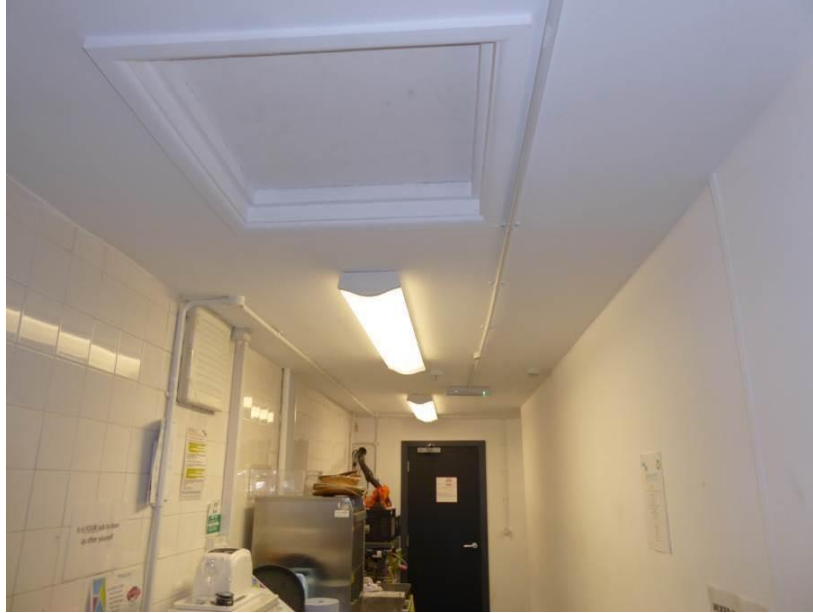
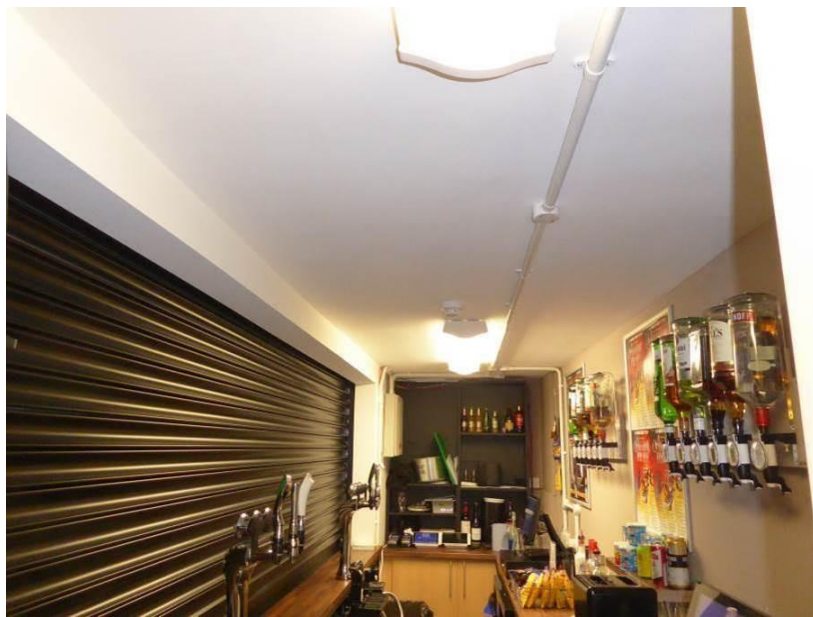
Beneath the ceiling there was a partition wall installed up to the underside of the ceiling and likely to be providing support at the mid-span of the bars. In the centre of the 3.5m span the ceiling was deflected at approximately 30mm, which is above the acceptable serviceability limit. Presumably the deflection occurred before partition wall installation.

Photos 8 and 9 – Ceilings over the Servery and the Kitchen.

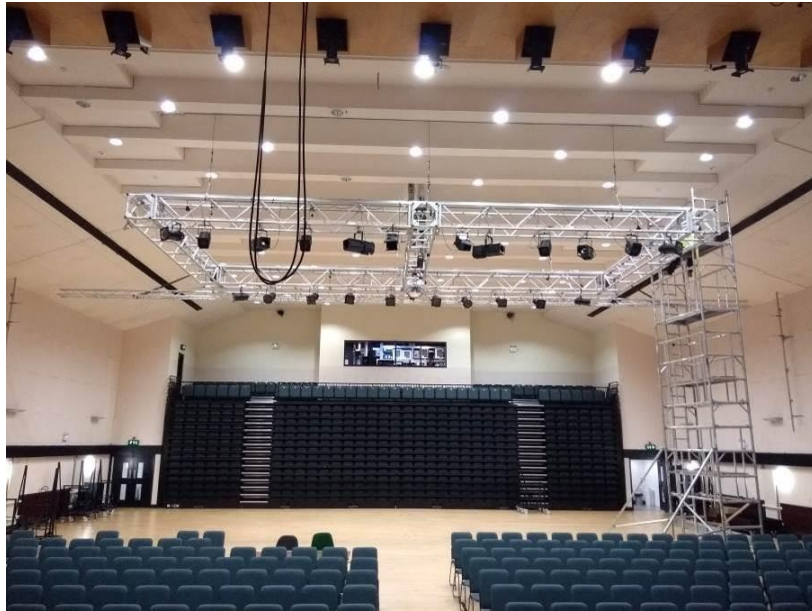
- 6.3.1 Access beneath the ceiling was provided from a scaffold tower and it was restricted by the lighting box and the retractable seating. The above access was provided over the central, flat part of the ceiling, although the timber floor did not allow us to inspect details of the construction in the whole area. There was no safe access above the side vaults of the Auditorium ceiling.

Photo 10 – Auditorium, retractable seating and light box.

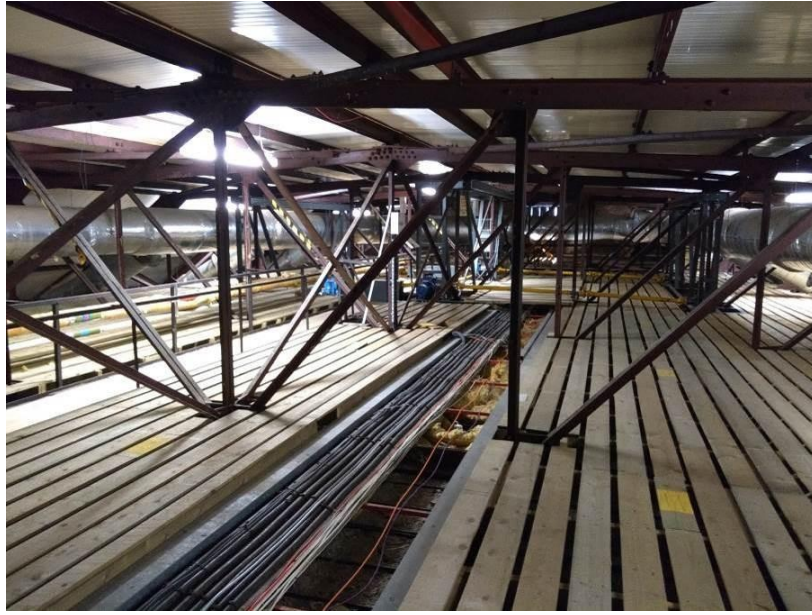
The ceiling was suspended from the roof structure, formed of steel trusses spanning over the auditorium, approximately 24.0 meters. The truss type was flat vault gambrel truss. Spacing of the trusses was approximately 3.8m. See Appendix B for schematic drawings of the structure over the auditorium.

Photo 11 – Loft above Auditorium.

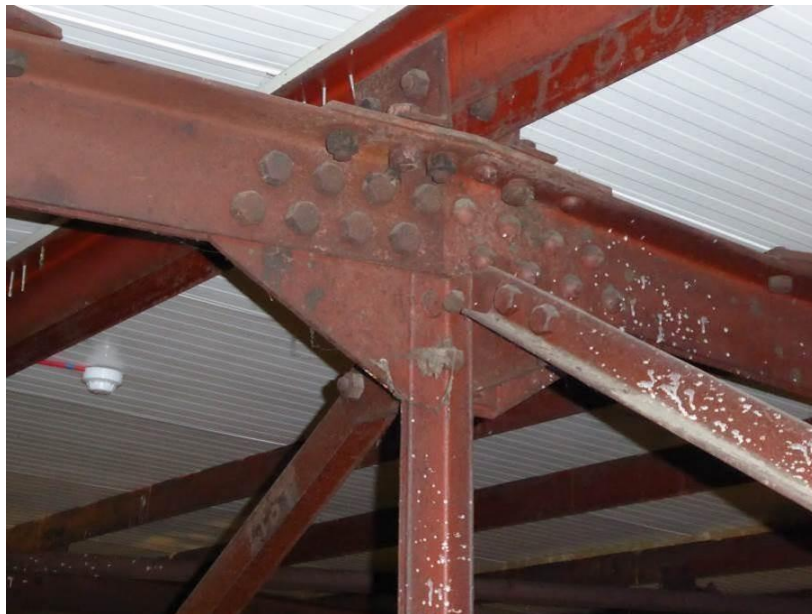
The connections in the trusses were formed with metal plates fixed to sections forming chords and struts with rivets and/or bolts. Presumably trusses had been divided into sections for transport and assembled on site.

Photo 12 – Truss connection.

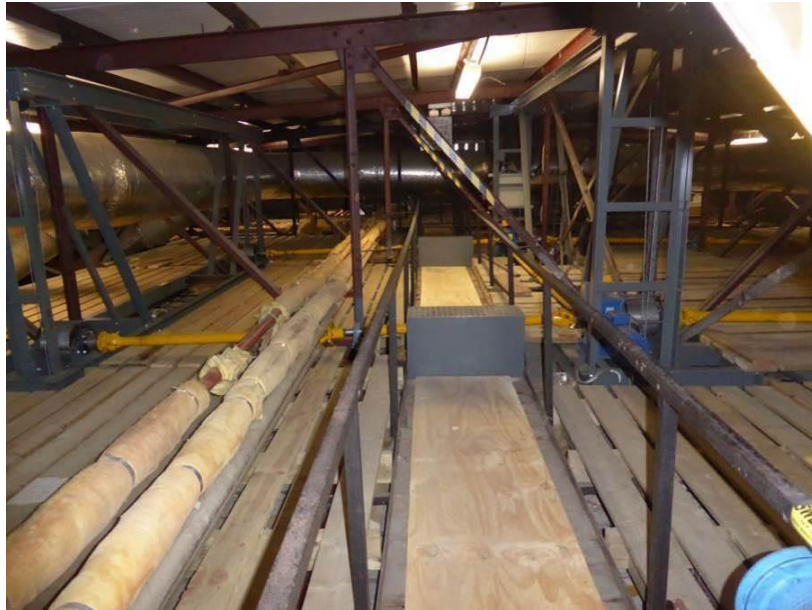
Beside the plastered suspended ceiling, the roof structure supported services (ventilation ducts, heating system, light box hoist, data and electric cables) and a timber floor.

Photo 12 – Services in loft above Auditorium.

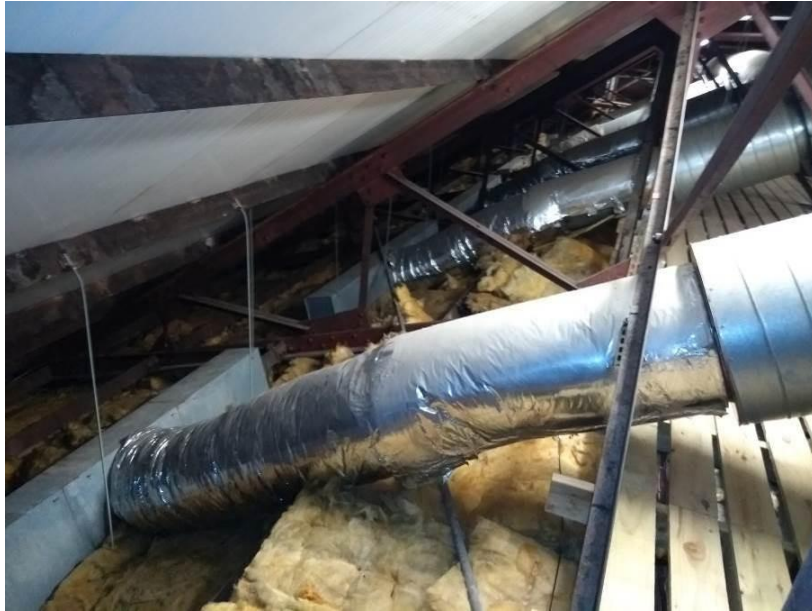
Photo 15 – Loft over vaulted ceiling -vent ducts,
no timber decking for access.

- 8.3 Safe access in the loft area over the Auditorium is required. All insulation and debris need to be removed and the Asbestos survey undertaken to confirm conditions for safe access. Means of safe access to the vaulted ceilings on the sides of the Auditorium need to be provided as well.

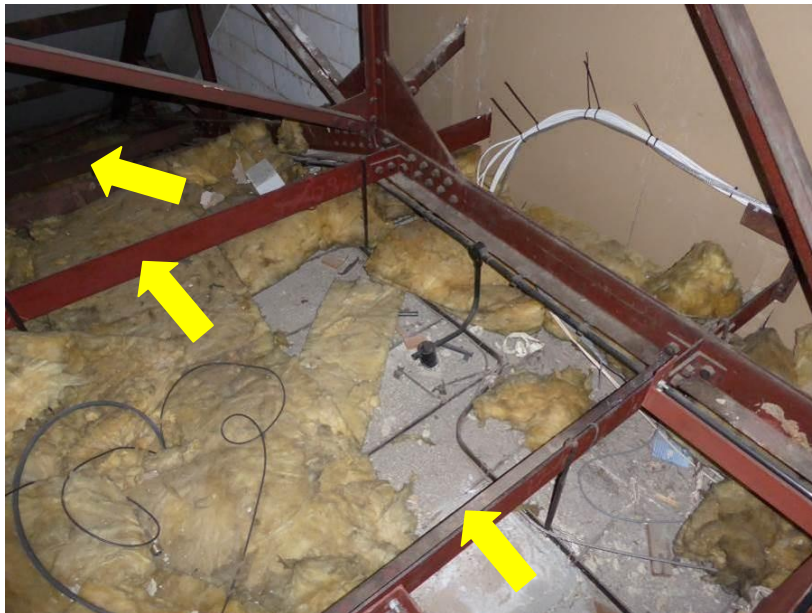
The substructure supporting the plastered ceiling was formed of steel angles, spanning between the roof trusses. The angles were fixed to the bottom chord of trusses at approximately 1.4m centres. The timber floor joists were bearing directly on the edge of the vertical arm of the angle. The floor structure was formed of 150mm deep by 45mm wide joists at 600mm centres and softwood floorboards placed with a gap between. The steel angles gave support to a flat ceiling over the central part of the Auditorium and vaulted ceilings on the sides, although the details differed depending on the area. The ceiling in the front part of the auditorium had been extensively altered, although the primary support system had not changed. Four types of ceilings were identified in the Auditorium area: high level ceiling, lowered ceiling, vaulted ceiling and stage ceiling. See following pages for details.

Photo 14 – Steel angles spanning between trusses
and supporting the suspended ceiling.

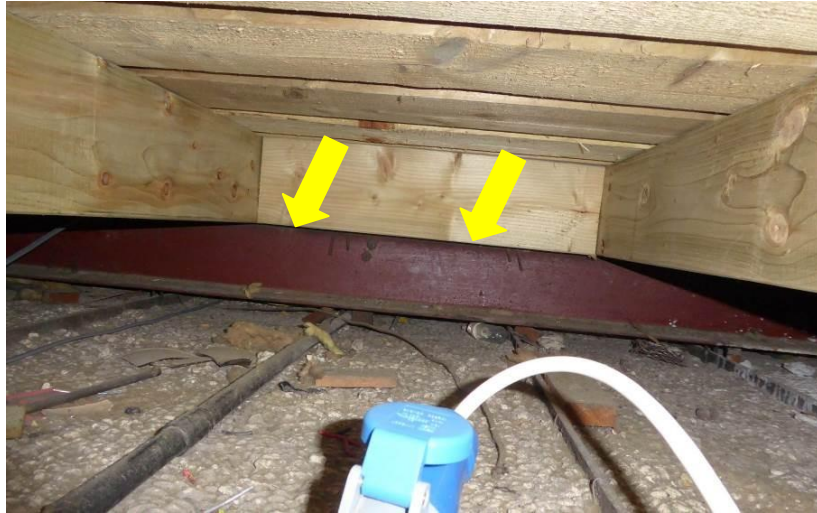
Part of ceiling was fixed directly to the underside of the steel angles, acting as secondary beams. The substructure was formed of mild steel flat bars (presumably 18x6mm) at approximately 350mm centres, fixed to the steel angles with metal wire ties, hooked over the vertical arm of the angle.

Photo 15 – Metal wire ties hooked over the angle arm.

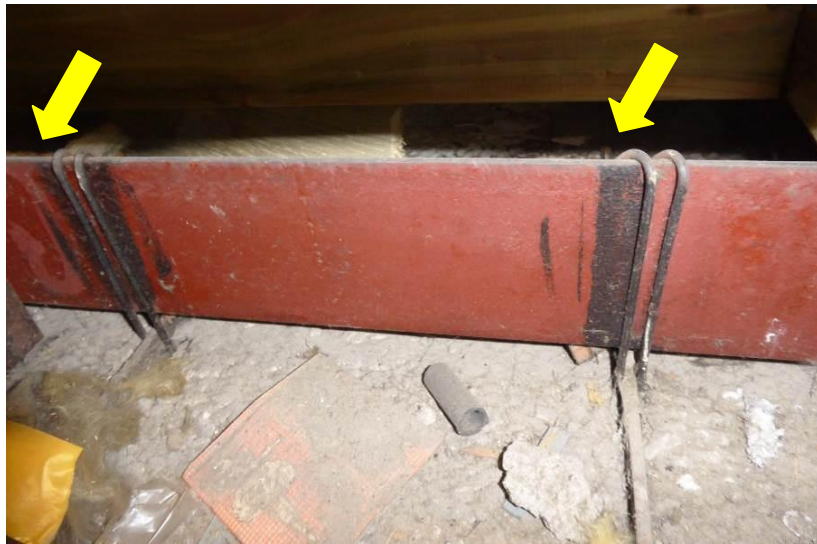
Photo 16 – Metal wire ties fixing flat bars to the angle.

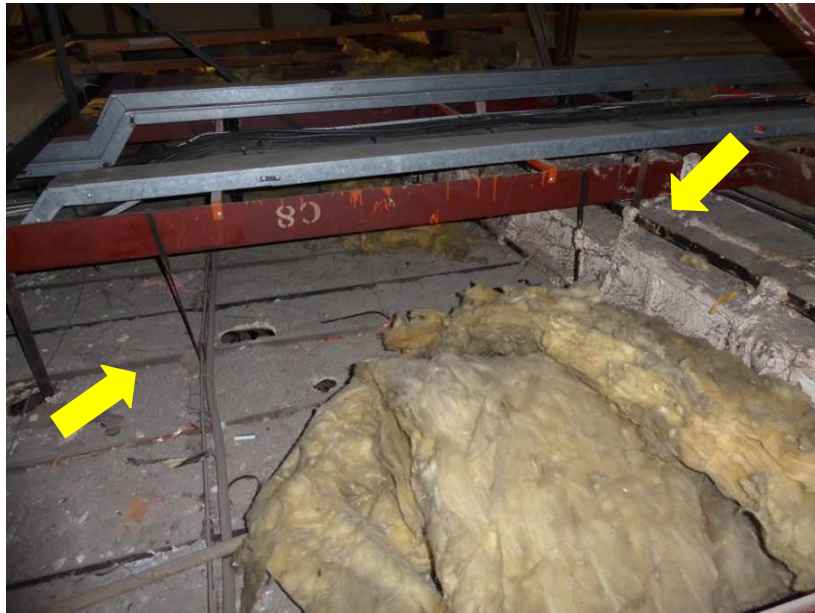
Part of the ceiling with solid work lowered below the supporting angles level, approximately 500mm (this distance may vary across the ceiling area). The substructure supporting the plastered ceiling was formed of mild steel flat bars placed in two layers and in orthogonal directions. The bottom layer was 18x6mm flat bars placed at approximately 350mm centres. Top layer was formed of 30x6 flat bars at approximately 1.0m centres. The top layer was suspended off the steel angles (secondary beams) with ties formed of mild steel twisted flat bars (15x3 mm). The ties were hooked over the vertical arm of the angle and over the flat bar. Metal wire was used generally to fix expanded metal lath to the bottom layer of the supporting structure, although hessian wadding ties had been noted in a few locations.

Photo 17 – Suspended ceiling, visible junction with high level ceiling.

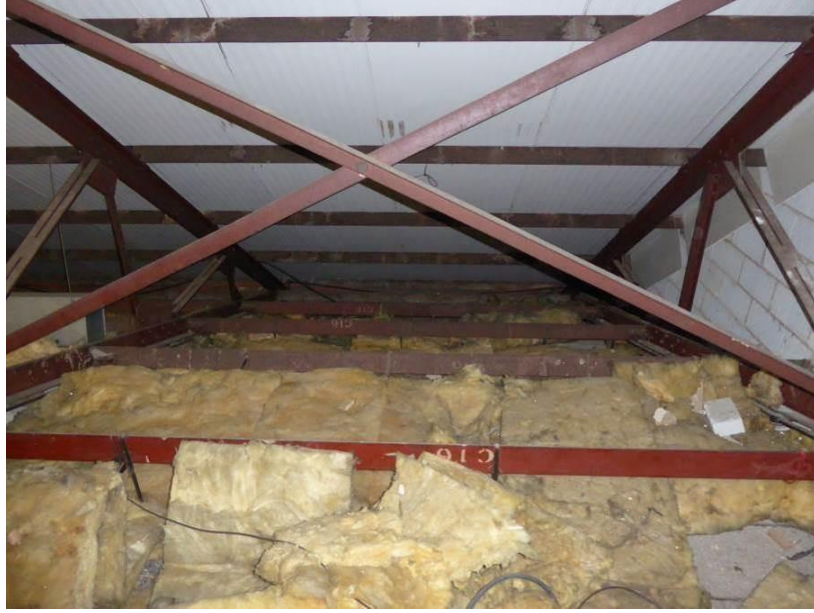
Part of the ceiling at the sides of the Auditorium, abutting the external walls. There was no good access to inspect details of the ceiling construction from above. Considering the details of construction viewed in the loft, we assume that the construction of the vaulted ceiling is like the lowered ceiling, where the ties were fixed to the substructure and supporting angles (secondary beams) at closer centres.

Photo 18 – Void over vaulted ceiling.

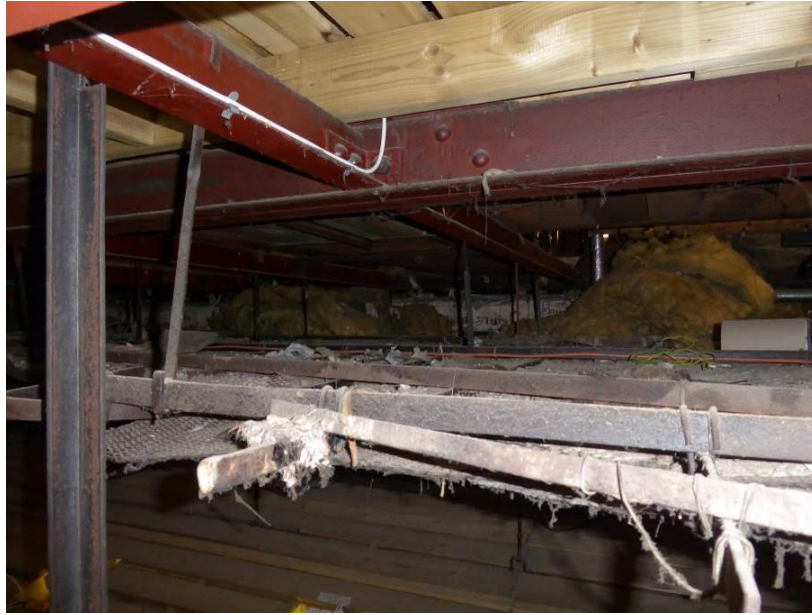
This item refers to the ceiling in the area abutting the stage. The original suspended plastered ceiling in this area was altered and covered with new structure formed of timber and plasterboard. The original ceiling's construction is equivalent to the lowered ceiling described above. The substructure and ties formed of flat bars were retained. The historic ceiling was locally removed to allow construction of the lowered ceiling and lighting platform over the Stage / front Auditorium. The modern ceiling and platform were suspended with flat bar ties (24x6mm) and equal angles (35x35x5) from the supporting angles (secondary beams). The connections between ties and platform substructure were bolted – either with a single bolt through the angle arm (in shear) or a single bolt welded to the tip of the flat bar and secured with a nut to the bracket or angle, fixed to timber structure of the platform. The new ties were penetrating through the retained historic ceiling. The spacing of the ties was approximately 2.0m along the secondary beams (angles). The lighting fixtures were suspended directly from the secondary steel angles or from the lowered ceiling structure.

Photo 19 – Historic ceiling substructure.

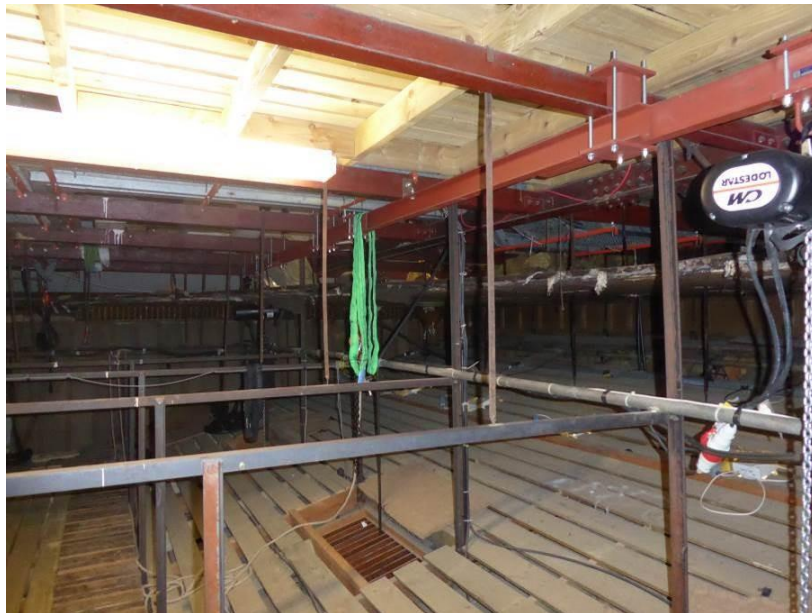
The timber structure of the platform was formed with 150mm deep by 47mm wide timbers installed at 450mm centres. Every second joist was suspended to the supporting (roof) structure with metal ties. The deck was formed with softwood floorboards installed with gaps between.

Photo 20 – Steel subframe supporting lighting platform.

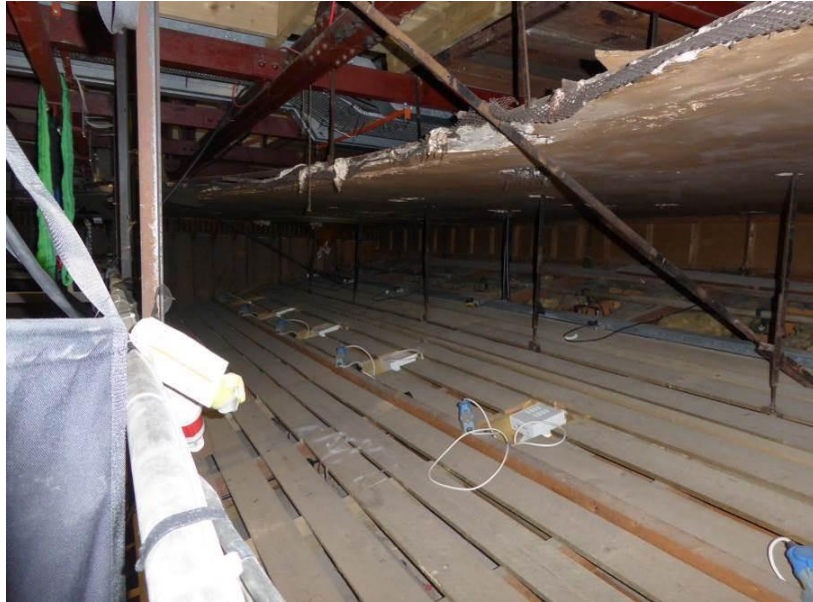
Photo 21 – Suspension of the lighting platform.

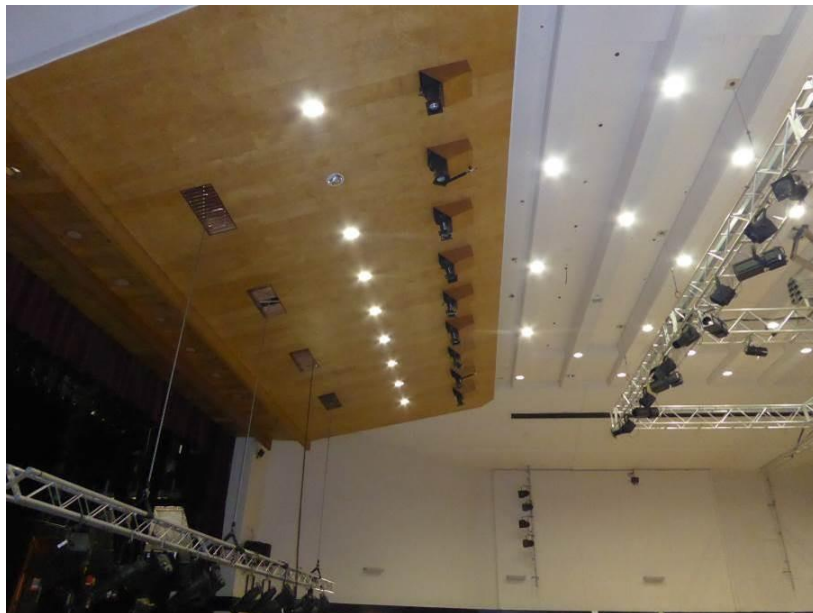
Photo 22 – Lighting platform, underside view.

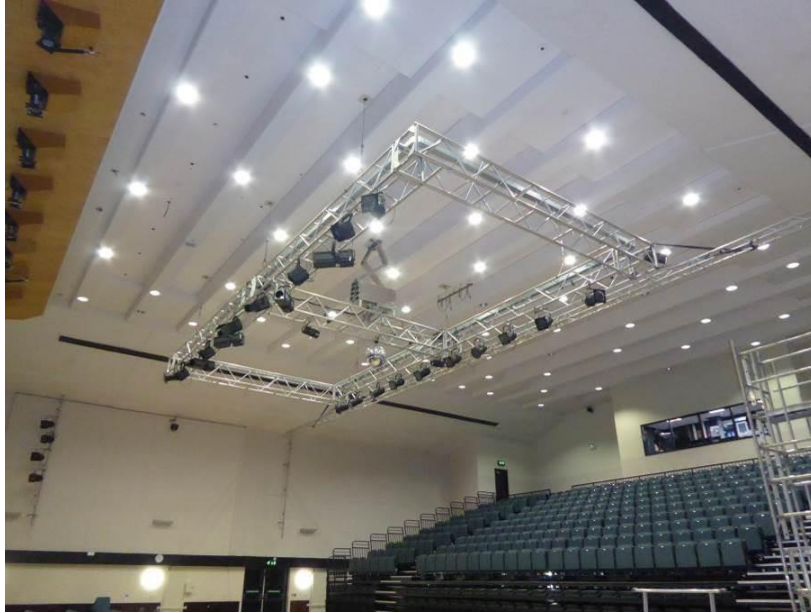
The ceiling was formed of solid work (cementitious mortar) applied to expanded metal lath. The lath was fixed to the ceiling's substructure with metal wire. The finish was indeterminate (possibly anhydrous plaster). The decorative plasterwork was cast fibrous plaster panels (hemihydrate plaster and hessian / timber reinforcement). The ceiling over the Auditorium comprised a large flat area in the centre and vaults on the sides, along the external walls. At the junction of the flat and vault ceilings a strip of ceiling was lowered and the step was finished with decorative Greek key panels.

Photo 23 – Ceiling over the Auditorium.

The Greek key where inspected was cracked in several locations and unsound. The decorative panels are structurally only self-supporting and lightweight; hence these defects have not caused ceiling failure. Panels assumed wadded only to 30x5mm flat bar and wadded at adjoining sections. It was not possible to ascertain if the wadding is reinforced or secure.

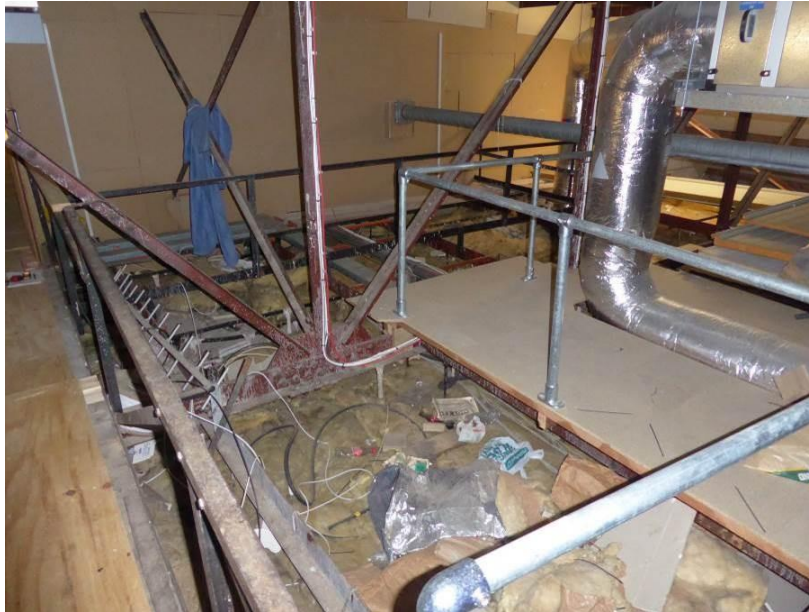
The ceiling was suspended from the roof structure, as described in paragraph 3.3.2. The trusses over the Alamein Room did not support the timber floor. The access walkway was constructed from a steel angle frame and chipboard. Ventilation ducts were hung down from the top chords or propped on the bottom chords of the truss.

Photo 26 – Loft above Alamein Room.

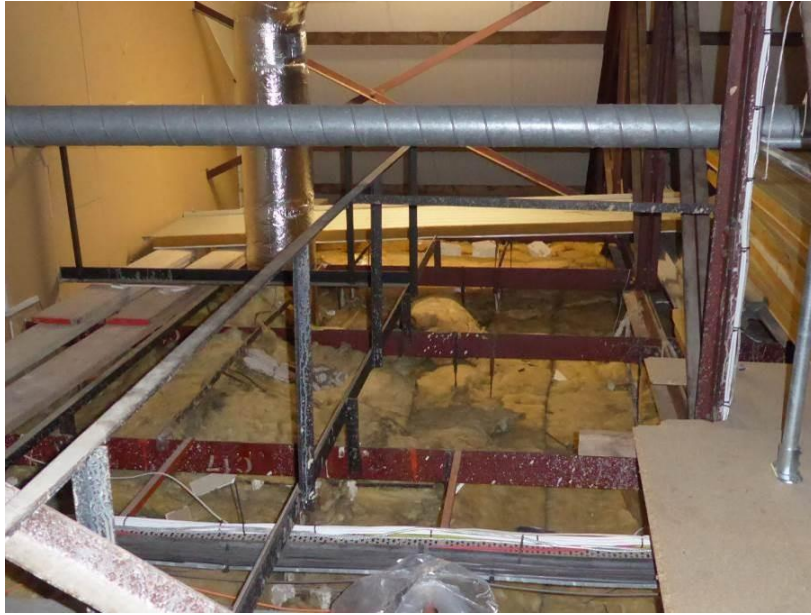
The thermal insulation placed on top of the suspended ceiling did not allow investigation of the details of construction. The ceiling plane had been lowered below the supporting angles (secondary beams) and twisted flat bar ties hooked over the vertical arm of angles have been noted. Wadding ties have been noted as well, although the metal ties seem to be the primary means of support, even if the number of ties seem to be lower than over the Auditorium. It is likely that the hessian wadding ties have been used to fix the decorative plasterwork elements.

Photo 27 – Ceiling above Alamein Room.
