**City Hall Salisbury
Malthouse Lane, Salisbury
SP2 7TU, UK**

**Suspended Plaster Ceilings
Inspection**

Prepared for
Kier Workplace Services

September 2020

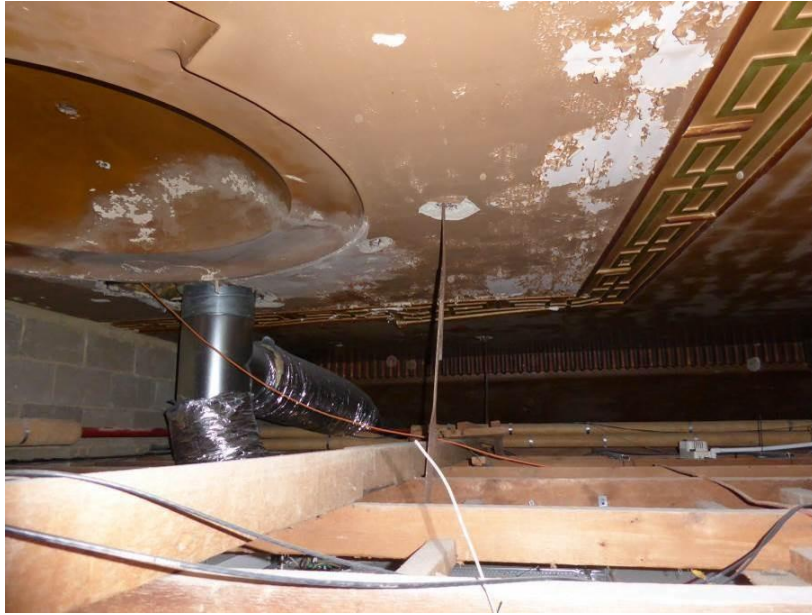
Numerous apertures were formed within the existing ceiling, where hangers had been installed to support the timber subframe for the lightweight, tiled suspended ceiling. Openings for ventilation ducts have been cut in the historic suspended ceiling as well.

Photo 30 – The underside of suspended ceiling over Alamein Room.

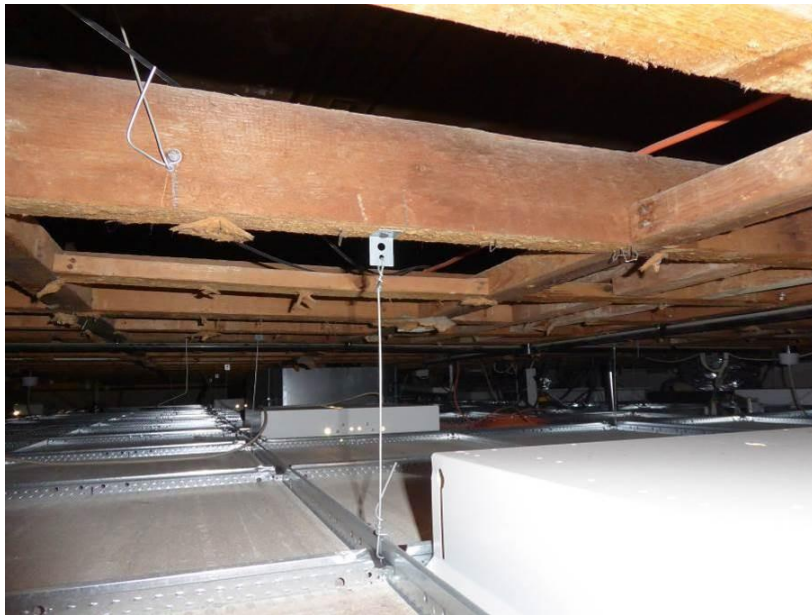
Photo 31 – Tiled suspended ceiling and timber frame over Alamein Room.

The installation of modern tiled suspended ceiling has not had impact on the historic suspended plastered ceiling. The timber frame substructure spans between masonry walls with intermediate ties fixed to supporting (roof) structure. These ties cause additional point loadings (approx. 0.9kN) on the steel trusses or secondary beams (angles). That loading should not have any impact on performance of the trusses, but may affect the stability of steel angles, hence location of these ties needs to be investigated in details to confirm location of the ties.
